# **Defibration of wood in the expedition huts of Antarctica: an unusual deterioration process occurring in the polar environment**

**Robert A. Blanchette and Benjamin W. Held**

**ABSTRACT.** Significant deterioration to the historic expedition huts of the Ross Sea region of Antarctica has occurred during the past decades from exposure to the polar environment. One type of deterioration that has affected all of the huts is a chemical attack resulting in a defibration of wood. Wood surfaces have a rough, fuzzy appearance and consist of white to yellow-brown masses of detached fibers. The damage is commonly associated with areas where water with dissolved salts is absorbed by wood. As moisture evaporates from the wood surface, exceedingly high concentrations of salt accumulate. Chemical reactions within the wood cause a corrosive degradation on the middle lamella region of the woody cell wall (the area located between cells that cements them together) and may gradually degrade all cell-wall layers. As the deterioration progresses, cells continue to separate and the wood is converted into masses of detached and eroded wood fibers. In advanced stages of attack, the wood structure and

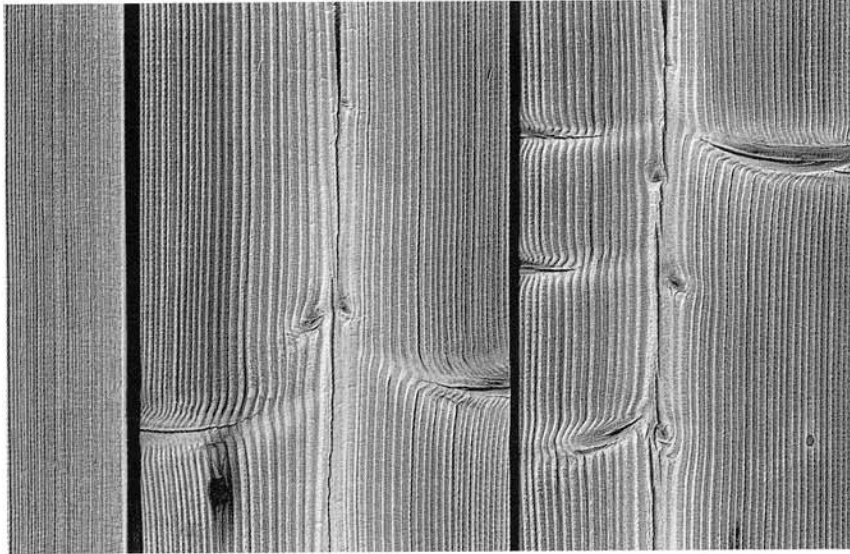
Fig. 1. Wind-eroded wood from the exterior of Shackleton's hut at Cape Royds.

This type of wood degradation is different from natural weathering of wood by the environment or by physical and photochemical reactions. In Antarctica, wind erosion is a significant factor that causes damage to wood (Fig. 1).

Wind with ice crystals and sand particles blasts the surface of the wood and causes it gradually to erode, a process known as corrosion. The Antarctic's strong windstorms and high-velocity katabatic winds have resulted in significant damage to historic expedition huts (Harrowfield 1981, 1996). Wind-borne particles do not erode wood uniformly. Areas between the rings (earlywood cells) are eroded before the thick-walled latewood cells. This results in the formation of erosion troughs and deeply furrowed wood surfaces that are commonly found on wood of the historic huts (Figs 2a, 3a, 4a). The effects from wind are different

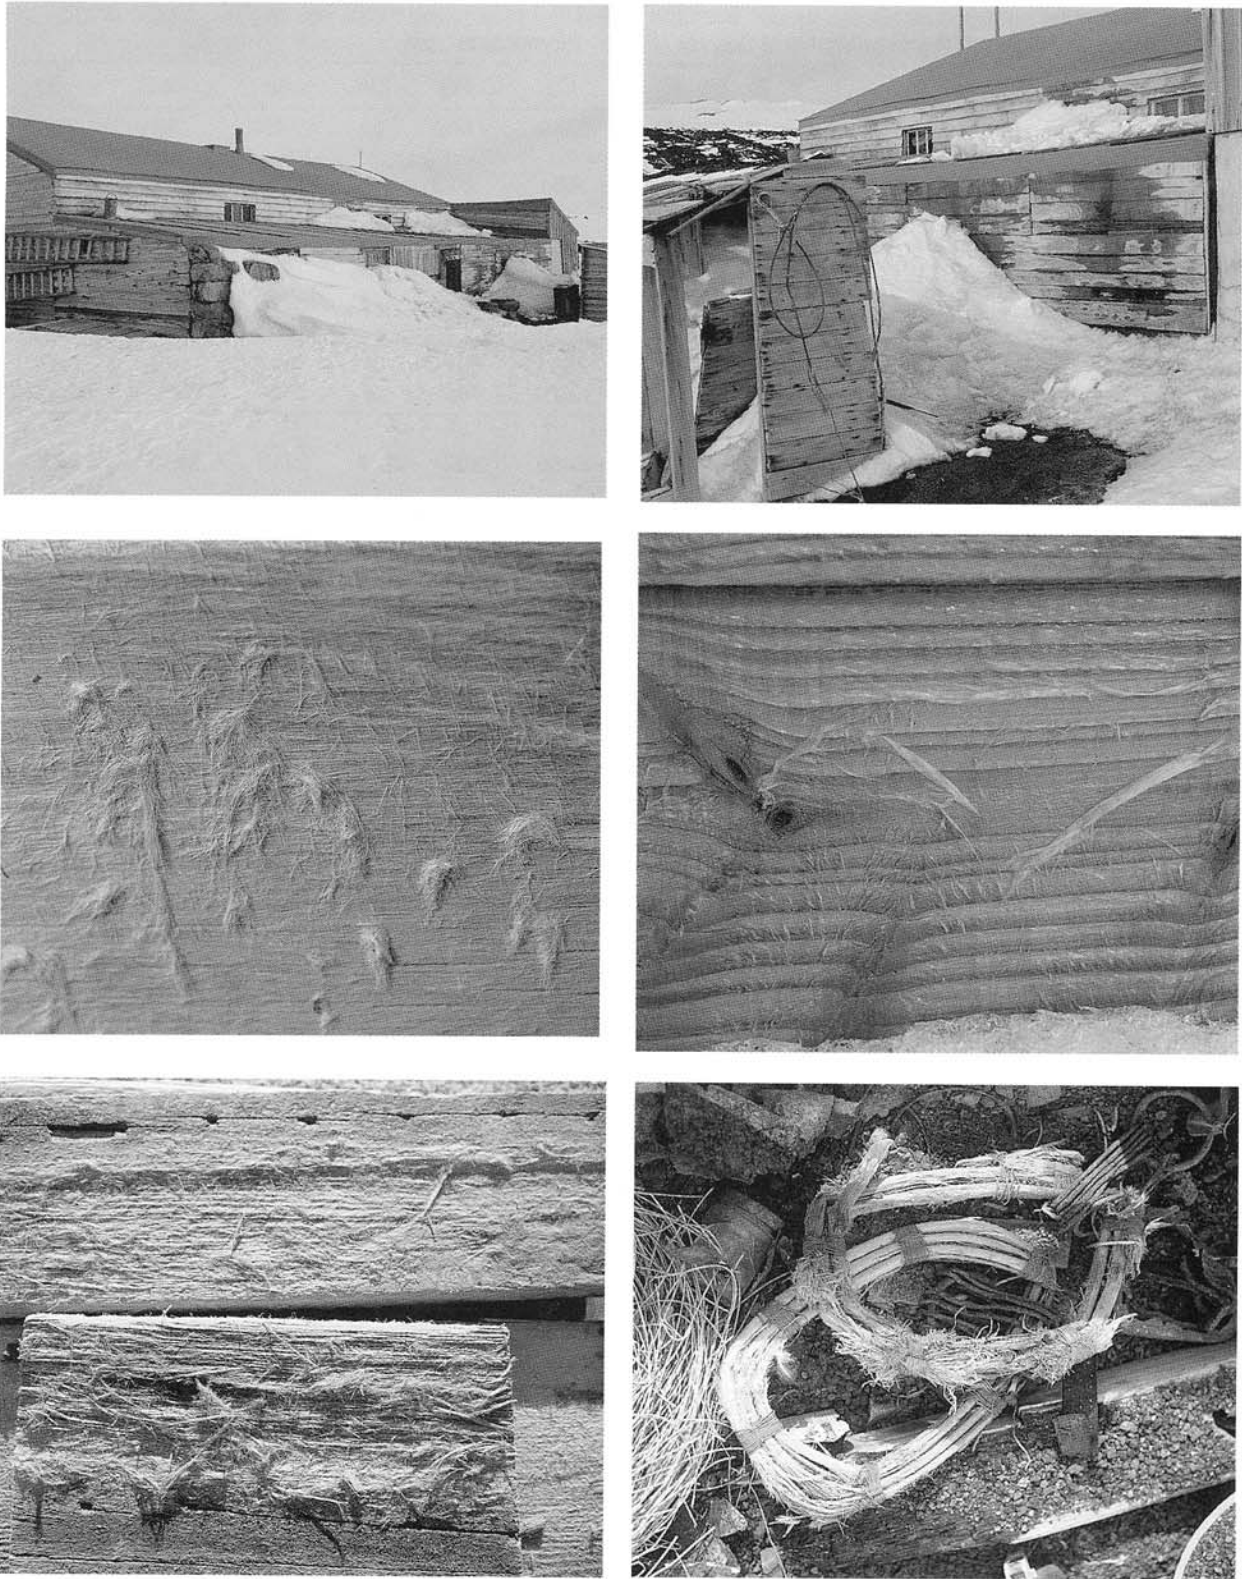
An extensive area of defibrillation damage is found on the west side of the Cape Evans hut facing the Ross Sea (Figs 2a, 2b). The surface of the exterior wallboards is bleached white and severely defibrillated (Figs 2c, 2d). When dry, the wood surface is covered with a mass of detached wood fibers. These dry fibers are often removed by the wind in unprotected areas of the hut. In addition, as snow and ice melt from the roof, water cascades down the sides of the hut walls and large masses of fibers are washed off (Fig. 2d). Repeated defibrillation and fiber removal from wind or meltwater results in significant thinning of the boards and in gradual destruction of the historic wood. In 1991, conservators replaced some of the exterior wallboards from the west side of the hut due to severe defibrillation damage (Fig. 2e). The authors' observations in 1999 and 2000 indicated that the replaced boards are already exhibiting significant defibrillation (Fig. 2d). Most of the original boards remaining on this side of the hut are severely affected and continue to experience successive defibrillation (Fig. 2c).

Elemental analyses using multi-elemental inductively coupled plasma atomic emission spectroscopy (Blanchette and others 1994; Munter and Grande 1981; US Environmental Protection Agency 1979, 1983) of defibrillated wood fibers, snow and ice from the roof, and meltwaters that dripped onto the exterior wall boards show exceedingly high concentrations of salts are present (Tables 1, 2). The roof of the hut at Cape Evans not only accumulates snow but high concentrations of sodium and chloride as well as potassium, magnesium, and sulfur (Tables 2, 3). Deposition of these elements is apparently from wind-blown seawater and salts that accumulate on the surface of the black volcanic sands. Mount Erebus, releasing plumes of

Fig. 2. Deterioration in Scott's hut at Cape Evans. 2a (top left). View of hut with snow seen on the roof and drifts of snow on the side of the hut. 2b (top right). Side of hut facing the Ross Sea. Snow melting from the roof drips down on the exterior boards and drifted snow melts onto external boards of the hut. 2c (middle left). Dry defibrated wallboard from the exterior of hut showing white masses of detached fibers. 2d (middle right). Wet defibrated wallboard from the exterior of hut. Water cascading off the roof has removed large masses of defibrated fibers from the wood surface. This board was replaced in 1991 and had already become severely damaged by December 2000. 2e (bottom left). Severely defibrated wood from the outside wall of hut, which was removed during conservation work in 1991. The affected boards were badly damaged and weakened by defibration. 2f (bottom right). Defibrated remnants of pony snowshoes made of rattan outside of hut.

Samples of dry defibrated wood had sodium concentrations of 98,650 ppm in comparison to wood from the hut interior with 2073 ppm and to sound modern pine wood (from a pine grown and milled in the United States) that had 7 ppm (Table 1). Wet defibrated wood fibers had concentrations of 3896 ppm sodium, indicating that the meltwaters had apparently leached out salts. The concentrations of salts in snow sampled from the roof varied, depending on when the sample was taken. A sample of freshly fallen snow had relatively low ion concentrations of sodium, sulfur, and chloride (Tables 2, 3), whereas older snow and ice from the roof had more than 5000 ppm sodium and had elevated concentrations of chloride, potassium, magnesium, and sulfur.

The data from the snow samples collected suggest that as snow and ice slowly melt on the roof, salts from wind-blown deposits and those in the snow are dissolved in the meltwater. The water and salt solution gradually drips directly onto the exterior wallboards. The solution is gradually evaporated from the wood surface, causing the salts to precipitate and concentrations to increase. Through time, extremely high salt concentrations build up and corrosive reactions to the wood take place. Moisture appears essential for the process to occur. In 2000, an unusual amount of snow had fallen and a greater than normal amount of meltwater was observed coming off the roof in December. Moisture, with associated dissolved salts, was covering almost the entire west exterior wall of the hut (Fig. 2b).

ground and salts precipitate. This also affects most of the wooden artifacts that are in ground contact. Wooden crates, dog houses, and other wooden items can be found with defibration damage. All of these woods absorb moisture from the ground and accumulate salts. Wood is not the only material to suffer from the degradative actions of the salts. Rattan pony snowshoes located outside of the hut were also found severely defibrated, demonstrating that the corrosive nature of the attack is not restricted to wooden artifacts (Fig. 2f).

- wooden artifacts.
3. Improve drainage of snowmelt from hut roofs. Of special concern is the melting of snow at the hut at Cape Evans, where water drips directly on the west exterior wallboards. An extension of the roof or other method to divert water from directly falling on the sides of the building is needed.

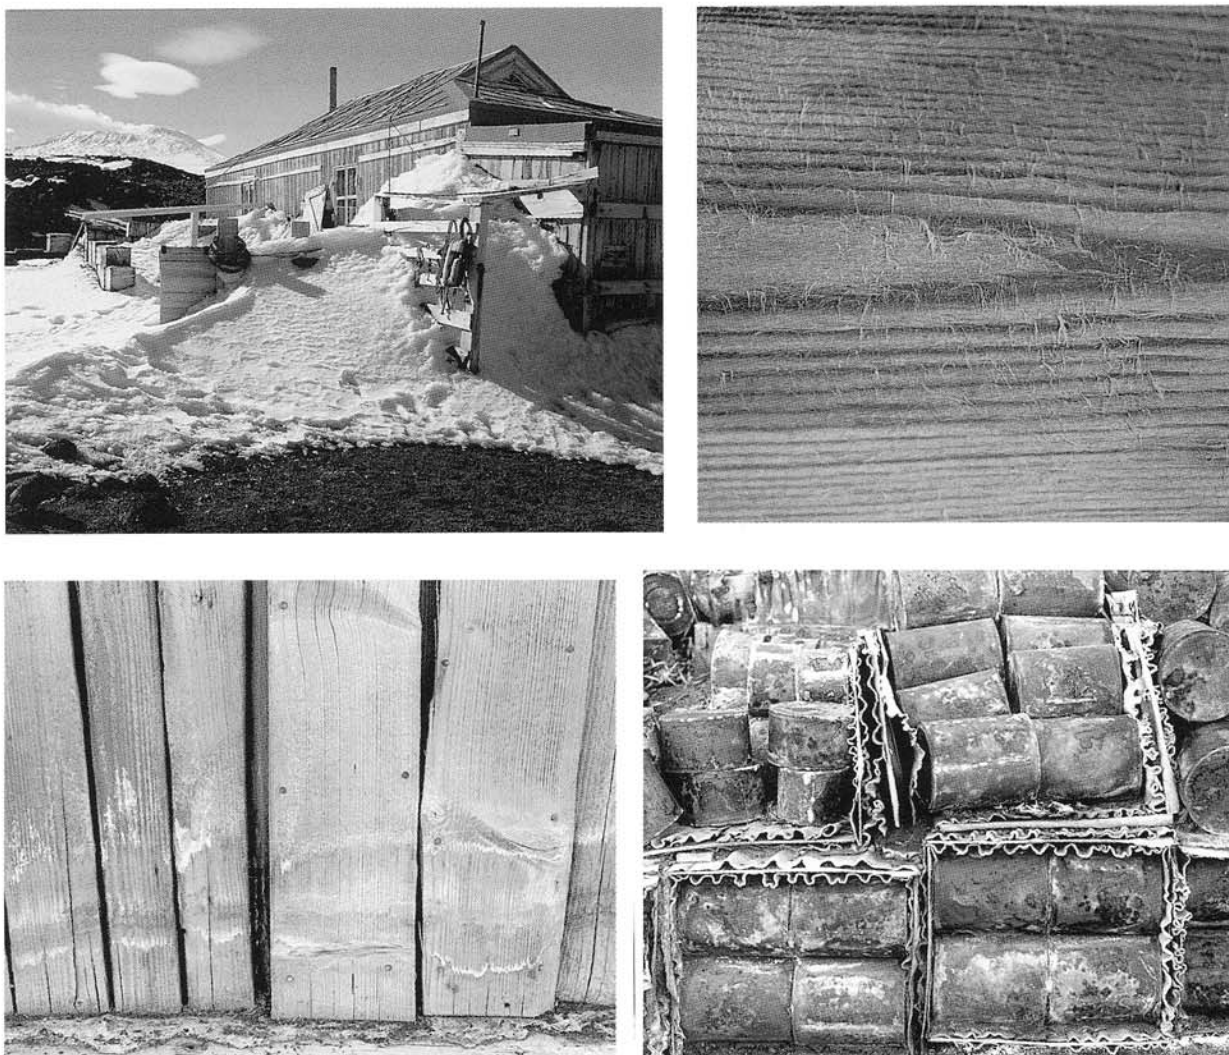
Some defibration is present on the exterior boards near the ground line at the hut at Cape Royds, especially on the north or stable side of the hut (Fig. 3). Wooden boxes containing stores located on the east and south sides of the hut are also affected. The birch plywood ('Venesta') boxes, selected by Shackleton to reduce the weight and size of the supply boxes during shipment, are damaged to a greater extent than other solid wood boxes. The plywood has become delaminated and surfaces are heavily defibrated (Fig. 3d). High salts and defibration are taking a heavy toll on these stores outside the hut.

An area of advanced defibration is located on the interior walls of the entry porch to the hut. The ceiling and parts of the walls have white to yellow-brown detached fibers that cover the wood surfaces (Fig. 3b). Moisture and salts are blown and trapped in the porch area, apparently functioning as planned by Shackleton to protect the living quarters from the Antarctic environment. As moisture evaporates, the salts accumulate and concentrations of salts exceeding 50,000 ppm were found in the defibrated wood (Table 1). Snow found in the hut also had high concentrations of salts, indicating that the wind-blown snow that enters carries considerable salt concentrations into the interior. Salts are also evident on wood inside the

Fig. 3. Deterioration in Shackleton's hut at Cape Royds. 3a (top left). View of drifted snow covering the side of the hut. 3b (top right). Defibrated board from a wall inside the porch of the hut, showing loosened surface fibers on the wood. 3c (bottom left). Salt accumulation on exterior boards of hut near ground. 3d (bottom right). Delaminated and defibrated wood boxes outside of the hut. These plywood or 'Venesta' crates made out of birch wood have defibrated surfaces.

the huts. This is especially important around the Cape Evans hut and in the stable area of the hut at Cape Royds. Improving the drainage will help reduce the moisture wicked up by the external hut wood and

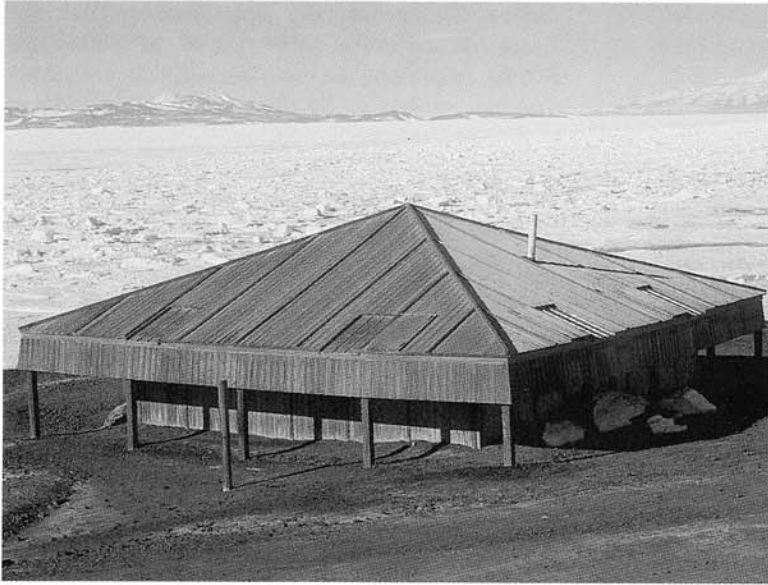
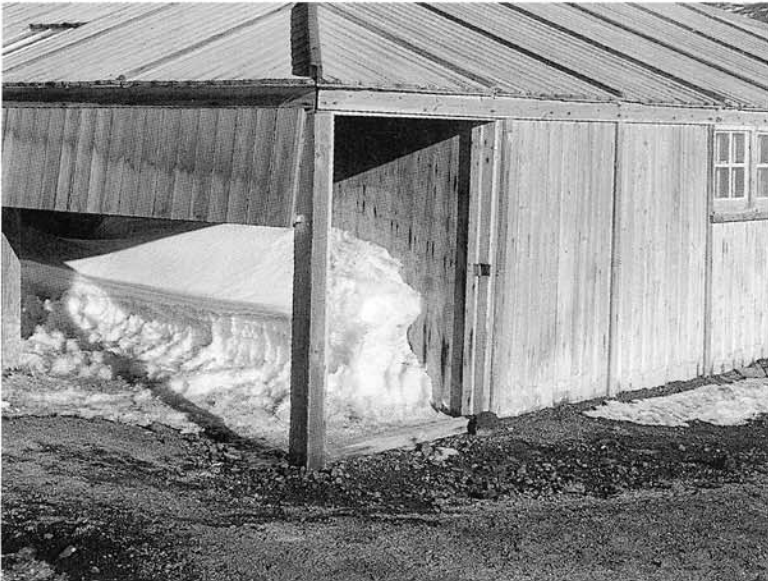
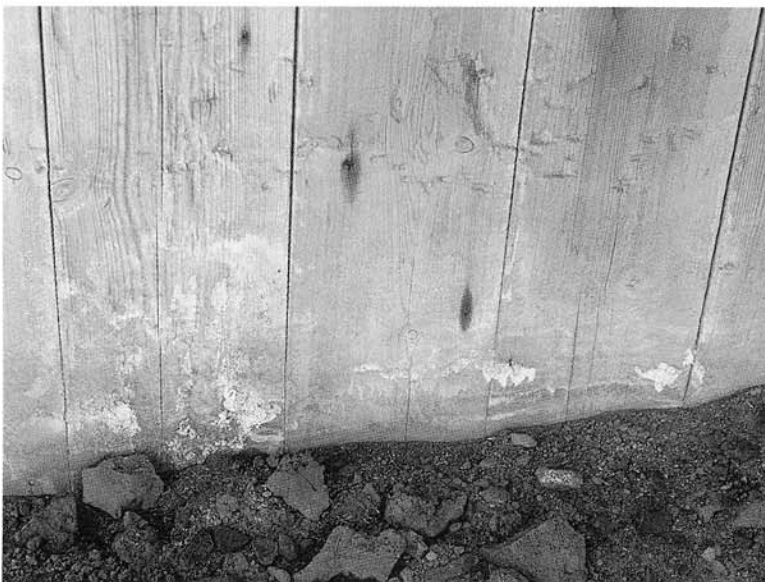
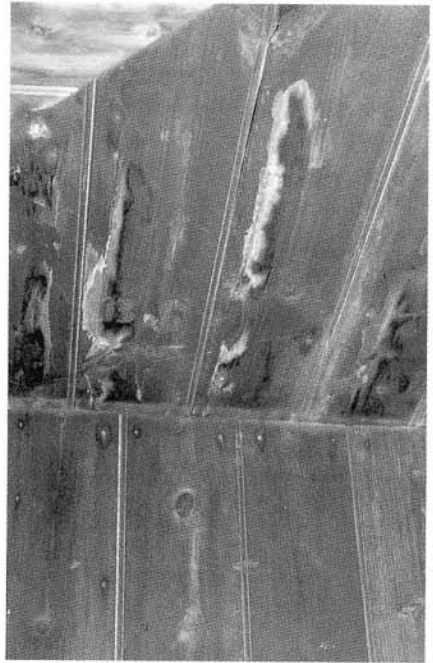
The greatest concentration of salts found from all hut samples was from exterior wood beneath the veranda of *Discovery* hut near the ground (Fig. 4). Two different samples analyzed contained 147,000 and 246,000 ppm of sodium (Table 1). Magnesium, potassium, aluminum, and other elements were also found in high amounts as compared to concentrations typical for sound pine wood. The architecture of *Discovery* hut allows snow and ice to

accumulate next to the hut under the veranda (Fig. 4b). Moisture and salts migrate into the wood and defibration results. The detached fibers, often with dirt and precipitated salt crystals, are not as easily seen as those on the hut at Cape Evans (Fig. 4c). The lack of excessive moisture dripping directly down the walls of *Discovery* hut apparently results in little disruption of the loosened surface fibers.

Wood around the windows on the veranda roof is also affected. Heat from the sunlight passing through the windows provides a microclimate that evaporates moisture from the wood, causing salts to accumulate and defibration processes to take place. As in the other huts, defibration is most apparent in areas protected from direct winds. Erosion of wood by wind is severe on some external woods of the hut. In areas where blasting winds carry snow, grit, and ice, the weakened fibers are readily removed. Salt accumulation can be found within the hut on wall and ceiling timbers, but the authors have observed no

advanced defibrillation on these woods (Fig. 4d). Moisture from snow entering the hut during storms and on the boots of tourists appears to be a continual source of water and salts into the interior, which may not only influence future wood defibrillation but serves to add humidity and salts that affect metal objects and other artifacts.

Fig. 4. Deterioration in Scott's *Discovery* hut at Hut Point. 4a (top left). View of hut and veranda. 4b (middle left). Snow accumulation under veranda and salt accumulation on lower exterior boards on side of hut without veranda facing the Ross Sea. 4c (bottom left). Salt accumulation and defibration of exterior boards near the ground on hut. 4d (top right). Salt accumulation on ceiling inside hut.

physically removing snowdrifts each spring will help reduce the amount of moisture that contacts the external hut wood.

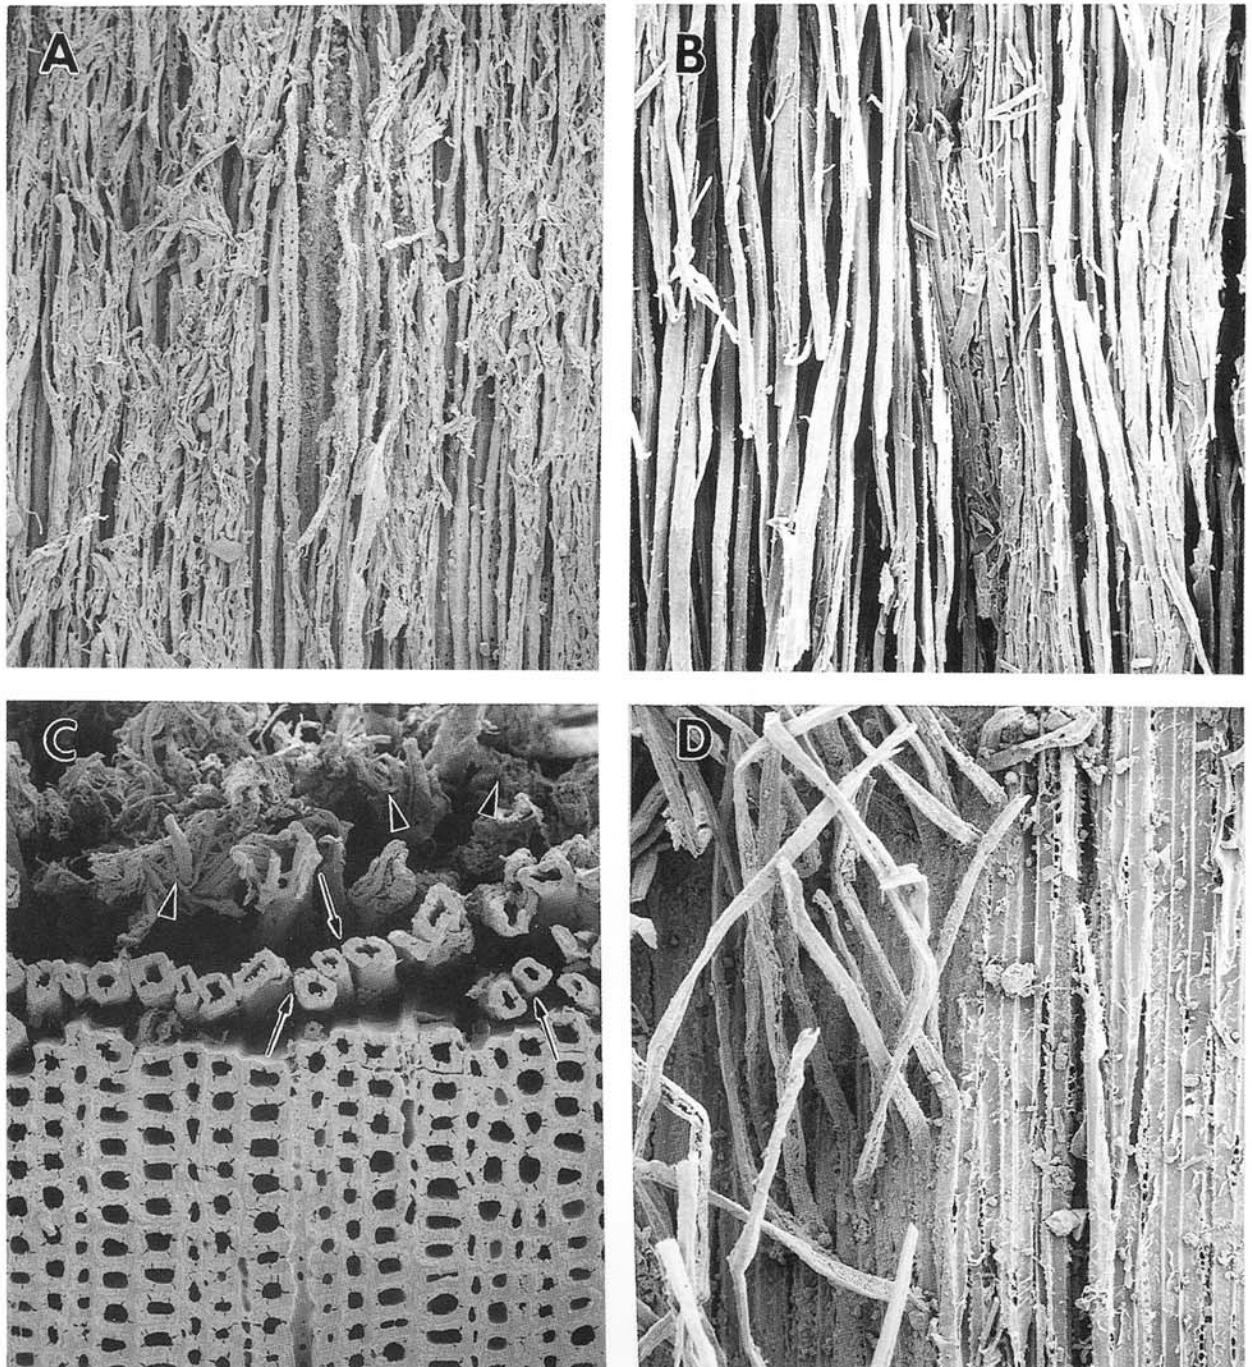
regions (Figs 5a, 5b). The secondary wall is least affected, and the detached cells consist primarily of the thick-wall secondary layers (Figs 5c, 5d). Even these secondary wall layers may be adversely affected through long periods of time, and cells from very advanced stages of defibrillation are eroded and fragmented. The polar environment, although very cold, is conducive to this type of degradation. During the Antarctic summer, snow and ground-ice melt, providing moisture that dissolves salts. In the Ross Sea region, salt migration occurs in soils, and thin crusts of salts are frequently found on the soil surface (Campbell and Claridge 1987). These salts, as well as salt from the sea, are widely dispersed by wind. Salt-enriched water in contact with the wood is absorbed and evaporated when temperatures are above freezing. Salts continue to accumulate and, without rainfall, exceedingly large concentrations develop. The chlorides, nitrates, and sulfates of sodium, potassium, and magnesium are corrosive on all materials, including metal, soil minerals, and wood. The rate of metal corrosion in Antarctica has recently been shown to be exceedingly high (Otieno-Alego and others 2000). In studies of steel coupons exposed to the elements in continental Antarctica, the rate of corrosion was comparable to coastal regions of Australia and nearly three times the levels observed in the sub-Antarctic islands. This investigation also showed that chloride and sulfur levels in rust from metals at the continental Antarctic sites far exceeded those of temperate areas (Otieno-Alego and others 2000).

Fig. 5. Scanning electron micrographs of defibrated wood from the historic huts. 5a. Defibrated wood from exterior wall of hut at Cape Evans, showing surface morphology of the affected wood. 5b. Defibrated wood from exterior of hut at Cape Royds. Wood cells separate from each other and become loose fibers. 5c. Defibrated wood from outside of *Discovery* hut. Transverse section of the wood showing sound wood (bottom of micrograph), the separation of wood cells at the middle lamella (arrows), and continued fragmentation and erosion of the fibers on the exposed surface of the wood (arrowheads). 5d. Defibrated wood from the exterior of the Cape Evans hut. Water and wind erosion has removed some of the older defibrated cells from the surface of the wood, leaving only a few detached cells. As the defibration process continues, other wood cells below the detached fibers will be degraded.
