FACTORS INFLUENCING THE DETERIORATION OF HISTORIC STRUCTURES AT DECEPTION ISLAND, ANTARCTICA

Benjamin W. Held, Brett E. Arenz and Robert A. Blanchette

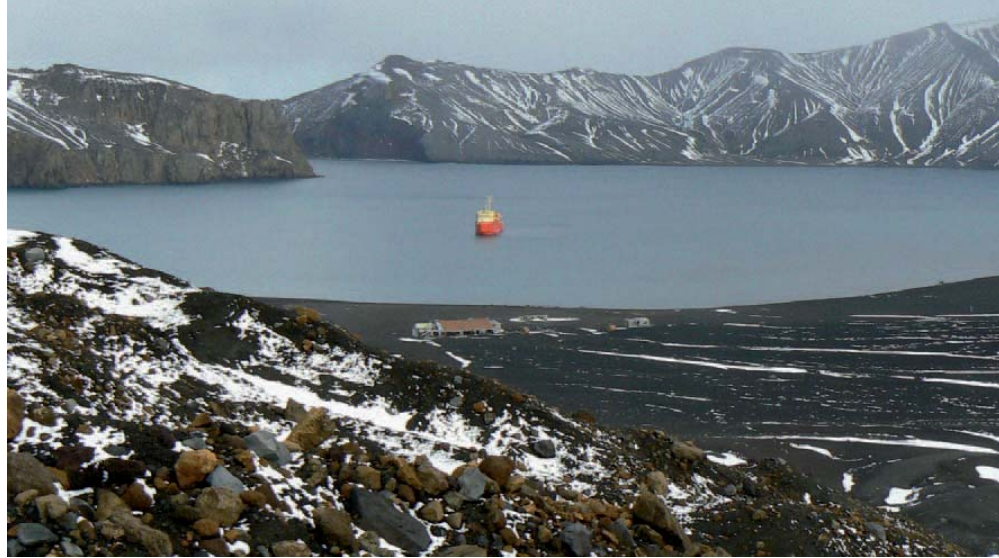
Figure 1.
Whalers Bay inside
the caldera of
Deception Island
where structures of
the historic whaling
station are located
along the shore.
Photo: Benjamin
Held

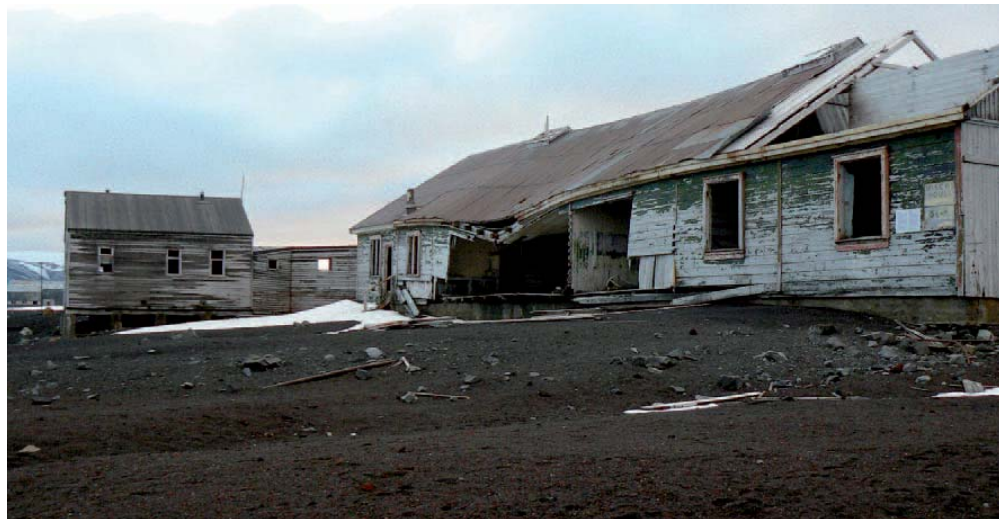
Figure 2.
Structures at the
whaling station at
Whalers Bay are
deteriorating. In
addition to historic
structures, there are
a number of other
wooden artifacts
and equipment from
the whaling period
as well as from
activities by the
British Antarctic
Survey located on
the island that are
also decaying
rapidly. Photo:
Benjamin Held

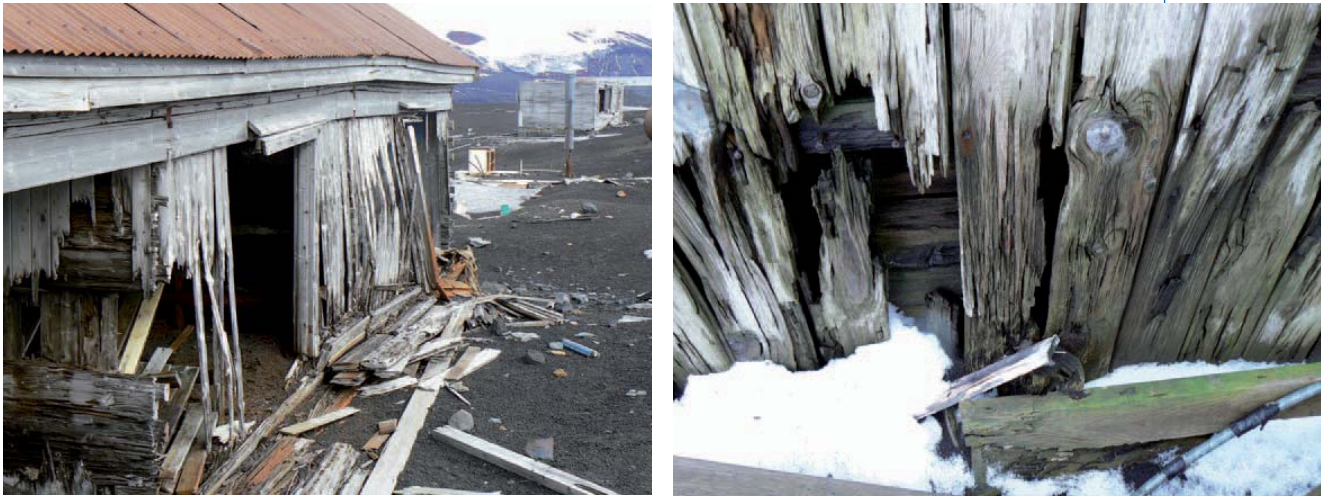
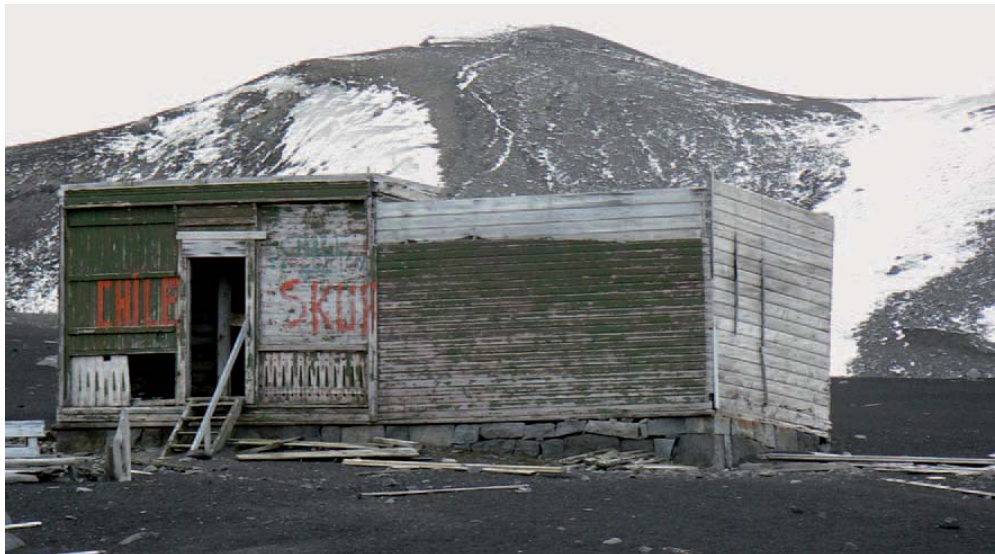
The wooden buildings and artifacts at Whalers Bay and wood remnants at Pendulum Cove have deteriorated extensively. In most areas where wood is in contact with the ground, significant decay has resulted. The decay commonly extends up from the soil to about a meter in the standing structures (Figure 3). Sufficient moisture and the presence of aggressive decay fungi have resulted in extensive damage. One structure exhibiting significant decay is the north side of the whalers' barracks (Biscoe House). This location has advanced stages of decay that have resulted in large holes formed in several areas of the wall (Figure 3). Many other parts of this structure are also affected and the damage is so severe that the structure is likely to collapse in the near future. A significant amount of mud has also entered the north side of the structure and filled many areas. Much of the wood in contact with the soil is being affected by decay fungi.

Figure 3. Left: The north side of Biscoe House showing advanced decay of the wall boards. Right: Decay is occurring in many areas well above

the soil line, as shown in these wall boards of the dispensary structure. Photos: Benjamin Held

The dispensary/store was partially destroyed and buried by a lahar resulting from the volcanic eruption in 1969. Sections of the structure have collapsed and others are also precariously close to collapse. Mud has also filled in and around the structure which has led to significant decay of wood in contact with the soil as well as in the wood well above ground level. Support posts in this structure are also severely decayed.

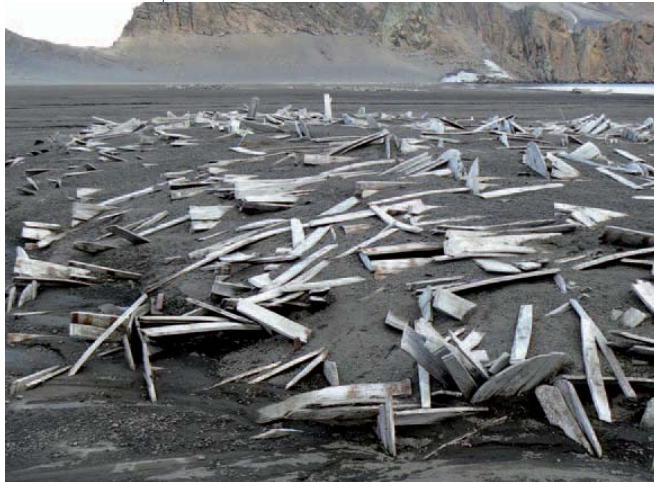
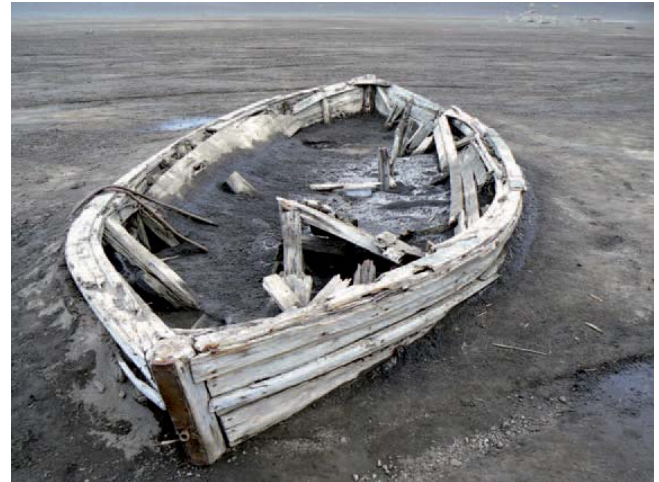
The Magistrate's residence and the Hunting Lodge, a prefabricated hut built by the British in 1955, are structures at the site that are in comparatively better condition than the others. This is in part because the buildings are on foundations that are above the soil (Figure 4). Without contact of the wood to the soil, decay is limited by reduced moisture and less contact with nutrients and soil microbes. Neither of these structures suffered from major damage from the lahar. However, the ground on the northwest corner of the hunting lodge

Figure 4. The Magistrate's residence has a solid foundation that has aided in avoiding deterioration by keeping the structure well above the soil. However, the roof has blown off exposing the interior to moisture. Photo: Benjamin Held

has been cut away by soil erosion and that part of the building is in danger of collapse. The roof of the Magistrate's residence has blown off and is lying nearby. The inside of this building is now exposed to the elements.

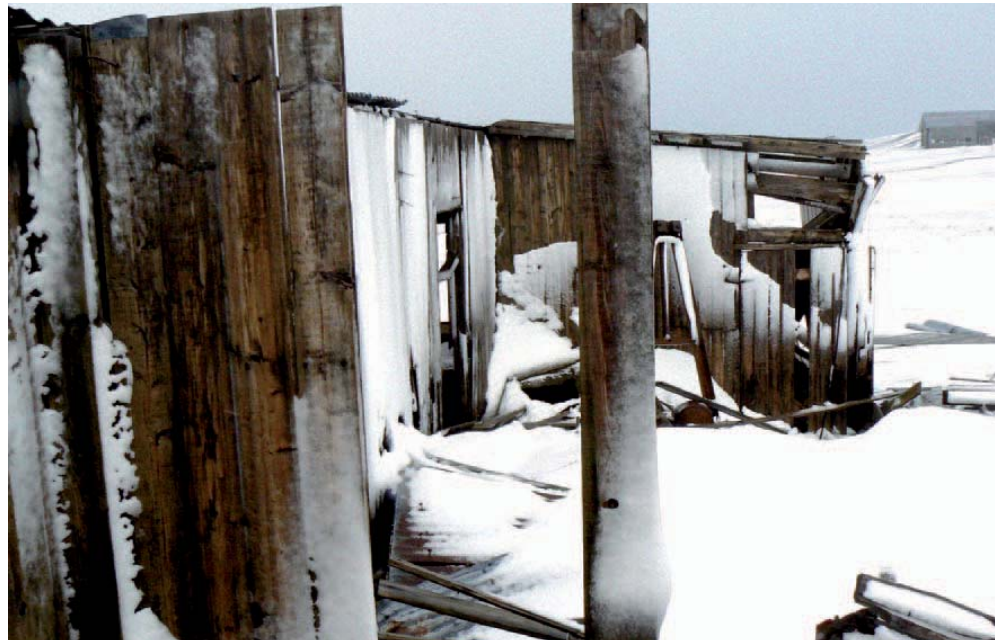
Deception Island has a polar maritime climate with a mean annual temperature of -3°C. Temperature ranges from -28°C to +11°C and an average high temperature during the months from October to April is 1°C. The mean annual precipitation is 560mm. Comparing Deception Island to that of Ross Island where the historic huts of Scott and Shackleton are located shows considerable differences in climatic conditions (Table 1). At Ross Island, the average yearly temperature is -19°C, average high temperature from October to April is -8°C and there is an average yearly precipitation of 190 mm. The maritime conditions of Deception Island favor warmer temperatures and increased precipitation. Since adequate moisture and temperatures above freezing are necessary for fungi to function, the conditions at Deception Island are allowing microbes to be active many more days per year than at Ross Island. In addition, the precipitation that occurs will likely be a heavier wet snow or rain/snow mix at Deception Island. Observations at the site during our assessment showed that a heavy wet snow accumulated on siding of the structures during storms and subsequent melting leaves considerable moisture on the wall boards and other above ground woods (Figure 7). It was apparent that this moisture absorbing into the wood was providing sufficient moisture for fungal growth and is the reason why decay extends up from the soil into the above ground wood structures. In areas where the bases of structures are buried in mud, decay begins and advances from the ground upward into the structure. Once decay occurs, the porosity of wood changes and the wood becomes more absorbent leading to even more water retention. This exacerbates the problem and allows for increased decay.

Figure 7. The north side of the dispensary at the end of a precipitation event showing accumulation of snow sticking to the wall boards. When this snow melts it is sufficient moisture to support fungal growth and decay.

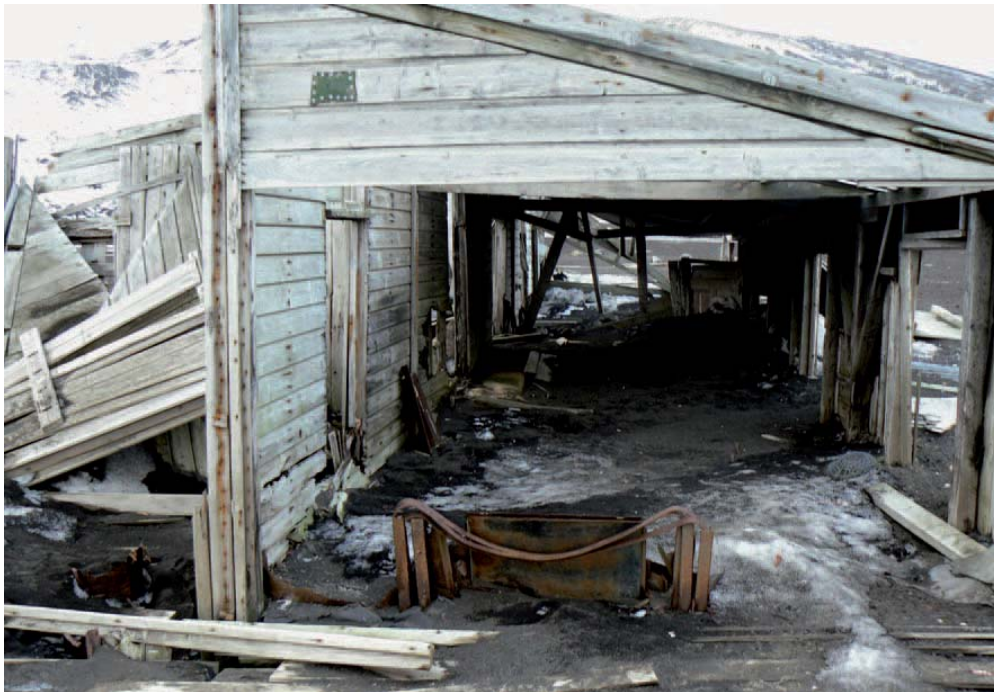
Lahars, specific to areas of volcanic activity, can cause dramatic destruction. Lahars occurred with recent eruptions in 1967 and 1969 and damaged structures at Whalers Bay and destroyed the Chilean base buildings at Pendulum Cove. There are clear implications that this phenomenon has contributed to the severe degradation and condition of the structures. There is a two-fold effect from lahars; first is the destructive force behind the flowing mud and water that damages or obliterates objects in its path and second, there is a change of environment that affects degradation processes in wood. The process of partially burying structures and artifacts brings soil, moisture and microbes that inhabit the soil into contact with the wood substrate and creates an environment conducive for decay by microorganisms (Figure 8). This has led to advanced decay in buried wood and also leads to decay occurring in wood above ground where there is sufficient moisture. These damaging effects are also evident on other artifacts like the barrel remnants and wooden boats on the shore. Several boats are nearly buried and are breaking apart due to the loss of structural integrity caused by decay fungi. In contrast, the Magistrate's residence and Hunting Lodge were largely unaffected by the lahars have far less decay occurring. Generally, the wood of these structures is above the soil line and little to no decay is taking place. However, the Magistrate's residence has soil in contact with wood on the north side of the building that has allowed decay to occur in that area.

Figure 8.
The dispensary/
store has been
inundated with
mud from a lahar.
The mud holds
moisture and
microbes which
creates a con-
ducive environ-
ment for decay
to take place.
Photo:
Benjamin Held

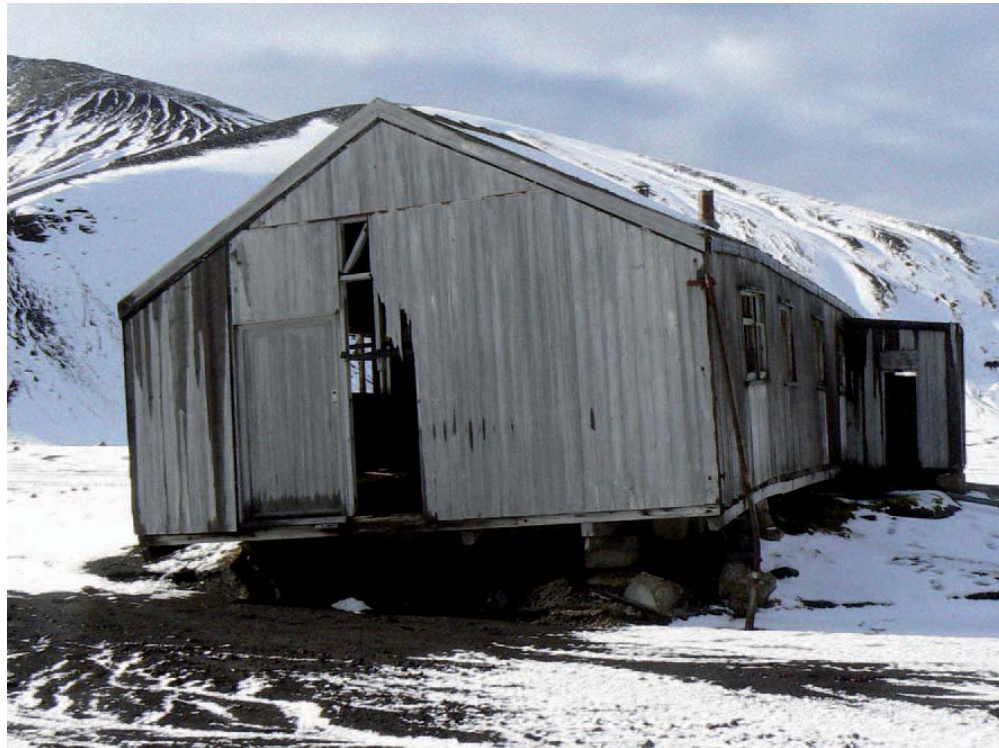
Figure 9.
The Hunting Lodge has significantly less deterioration than other structures at the site partly due to a high foundation keeping the wood well above the soil. However the left corner shows erosion of the foundation that is in danger of collapse. Photo: Benjamin Held

Many of the wooden resources at Deception Island are so deteriorated that very little can be done to preserve them. Among them, Biscoe House and the dispensary are precipitously close to collapse. Removing soil away from the base of the structures and artifacts where feasible is recommended to help arrest decay by limiting contact with soil moisture. Perhaps the most appropriate procedures are those that focus resources where conservation work could be feasibly carried out. For instance, repairing the roof of the Magistrate's residence would help protect one of the original structures at the site that is still in relatively good condition. Replacing the roof would protect the interior from further damage and the structure could possibly be used to house interpretive material. Also repairing the foundation of the Hunting Lodge that has washed away would greatly improve the structural stability of this building (Figure 9).
