EAST BASE, SOS: ASSESSMENT OF DETERIORATION AND RECOMMENDATIONS FOR CONSERVING THIS IMPORTANT ANTARCTIC HISTORIC SITE

Brett E. Arenz and Robert A. Blanchette

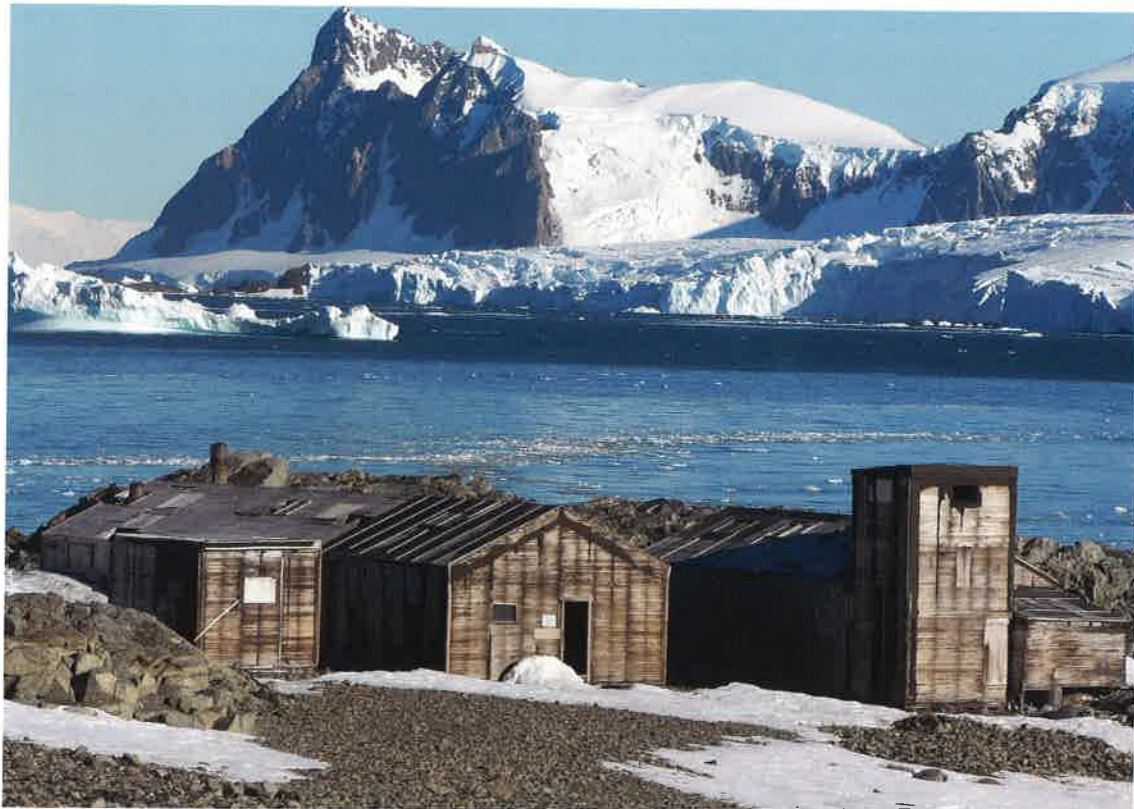
Fig. 1. East Base on Stonington Island, Antarctica showing the Ronne hut (left), Main Building (center) and Science Building with Met Tower (right) as they appeared during the assessment in January 2007.
Photo: Brett Arenz

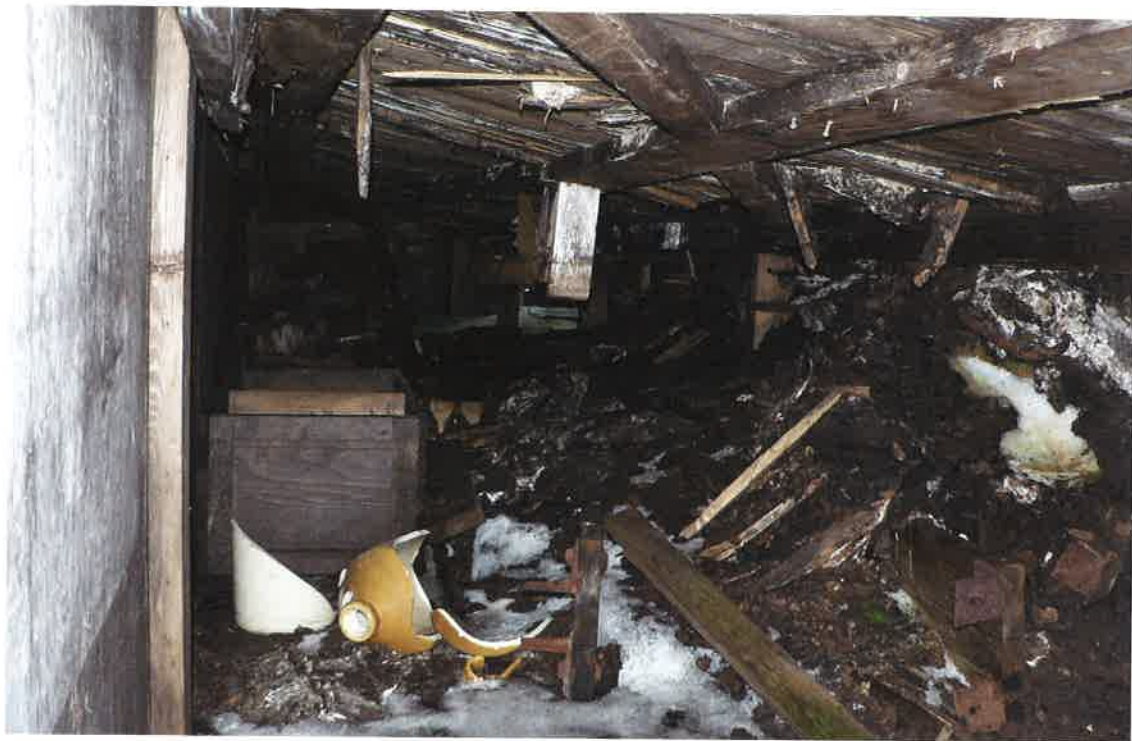
Fig. 2. The Main Building showing collapsing floor built by British Antarctic personnel from Base E. This floor was built 4 feet above the original floor and covers historic artifacts, debris and ice. Photo: Brett Arenz

been placed in a hole cut into the floor. The Main Building received the greatest modification of all three buildings as the original floor was apparently covered with a thick layer of ice when the British returned to Stonington in 1957 so they built another floor four feet above the original. A partitioning wall was constructed on the eastern side of the building which houses a room with the original floor. A large portion of the main building was used for storage and for seal processing as seal meat was used to feed the dogs on the sledging teams. Consequently the interior of the main building is filled with seal carcasses in addition to ice and other debris. The British-constructed floor is also collapsing in many areas making the interior of this building hazardous to enter (Fig. 2). There is a broken door on the north side of the building, and an entrance in the roof on the south side which provides entry via a ramp to the collapsing floor. The door on the eastern side of the building leading to the room with the original floor has broken off in the last 15 years, apparently due to corroded hinges. There is also a large number of missing roof timbers and wall slats on the building with many more timbers missing on the main building than the two other buildings (Fig. 3).

The deterioration occurring at East Base is significant and repairs, conservation and additional investigations are needed as soon as possible. All open or missing doors and windows in the three buildings should be repaired or replaced to preserve the remaining integrity of the structures. In the Main Building, all three entrances need to be closed to the outside environment; the broken door on the north side of the building, the open ramp entrance on the roof and the door on the eastern side. As a temporary repair, the eastern side door from the inside of the building was nailed shut during our visit but a more permanent repair is needed. If regular access for visitors to this room is desired, a door with non-corrodible hinges should be used. The Ronne Hut door is still in place but open and only a snow drift presently inside the room prevents the door from being completely opened. If this is to be a secure site for artifacts, the door must be secured. Repairing these openings will help protect the structures from the very high winds which occur here as well as helping to prevent some of the snow drifting inside, which when it melts will provide sufficient moisture needed for fungal growth to occur.

Although Stonington Island is relatively remote, it does receive visits by cruise ships, and over 600 signatures were counted in the guestbook that had been left by the conservators in 1992. Given current trends of increasing Antarctic tourism, this very significant historic site will undoubtedly have even more visitors in the future. Considering that parts of the huts could represent safety issues, particularly the false floor in the main building, work is needed urgently to deal with these concerns.

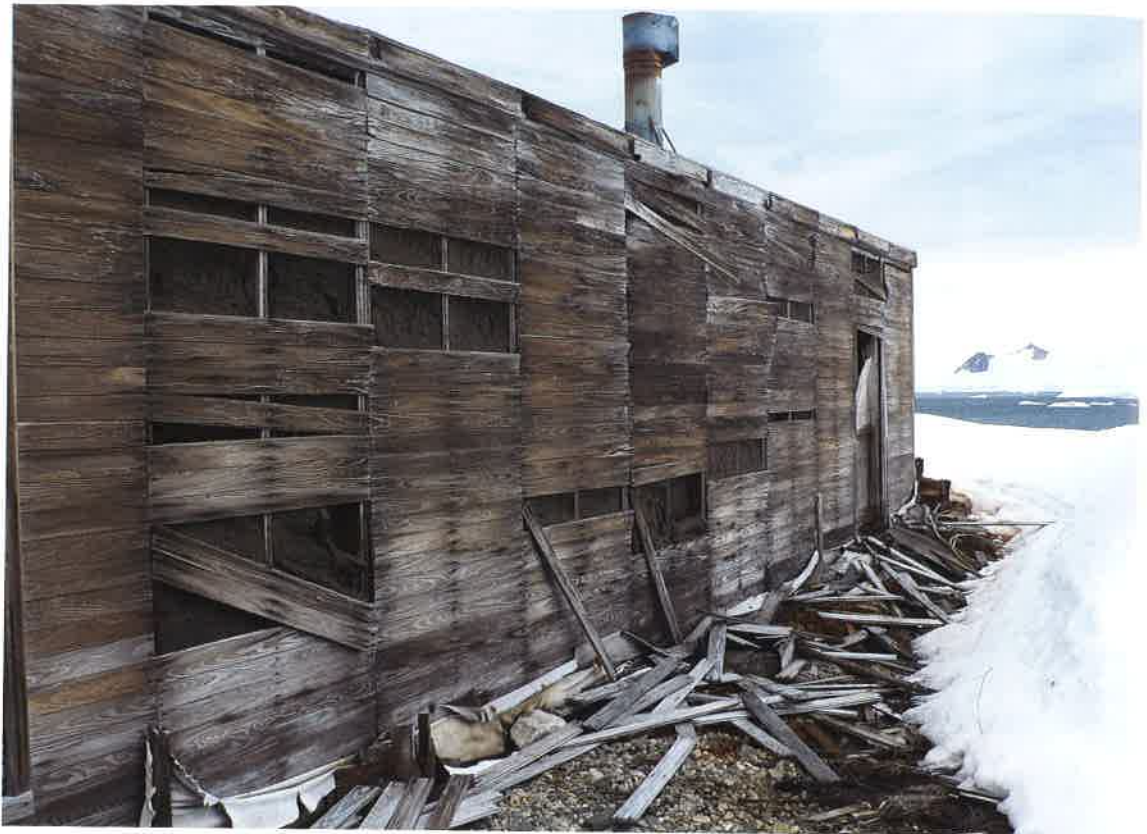
Fig. 3. Exterior north wall of the Main Building showing the loss of many wall boards.
Photo: Brett Arenz

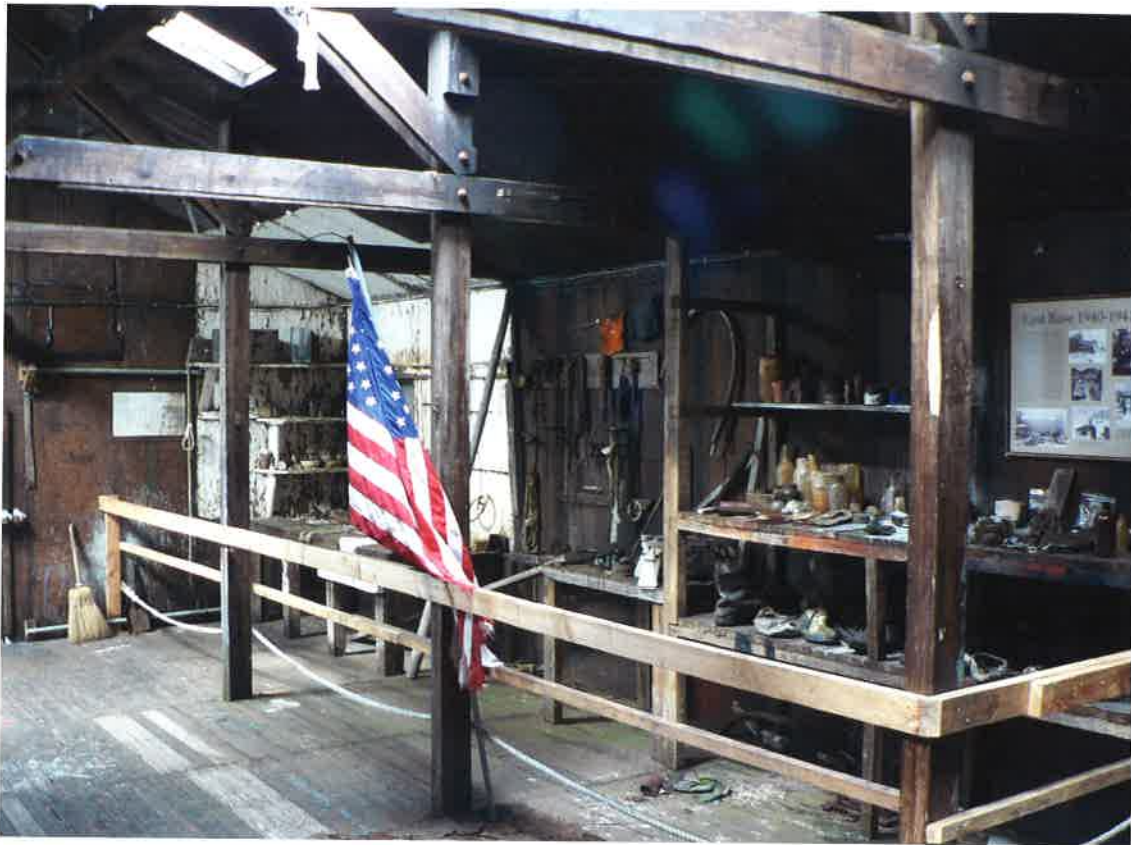
The Science Building and Ronne Hut are in relatively good condition compared to the Main Building. Because they were comparably weather tight, the conservators in 1992 chose the Science Building to set up a museum type display of artifacts that had been found outside (Fig. 4). These artifacts were from both the 1941 USAS and 1947 RARE Expeditions. Additionally, there are some materials, such as sledging flags and dog harnesses, from the time after 1948 when the British occupied the structures. A cache was also made in the Ronne Hut for additional artifacts that the 1992 conservation crew thought deserved additional protection.

Fig. 4. Inside the Science Building showing the artifact display set up by the 1992 conservation team. Photo: Brett Arenz

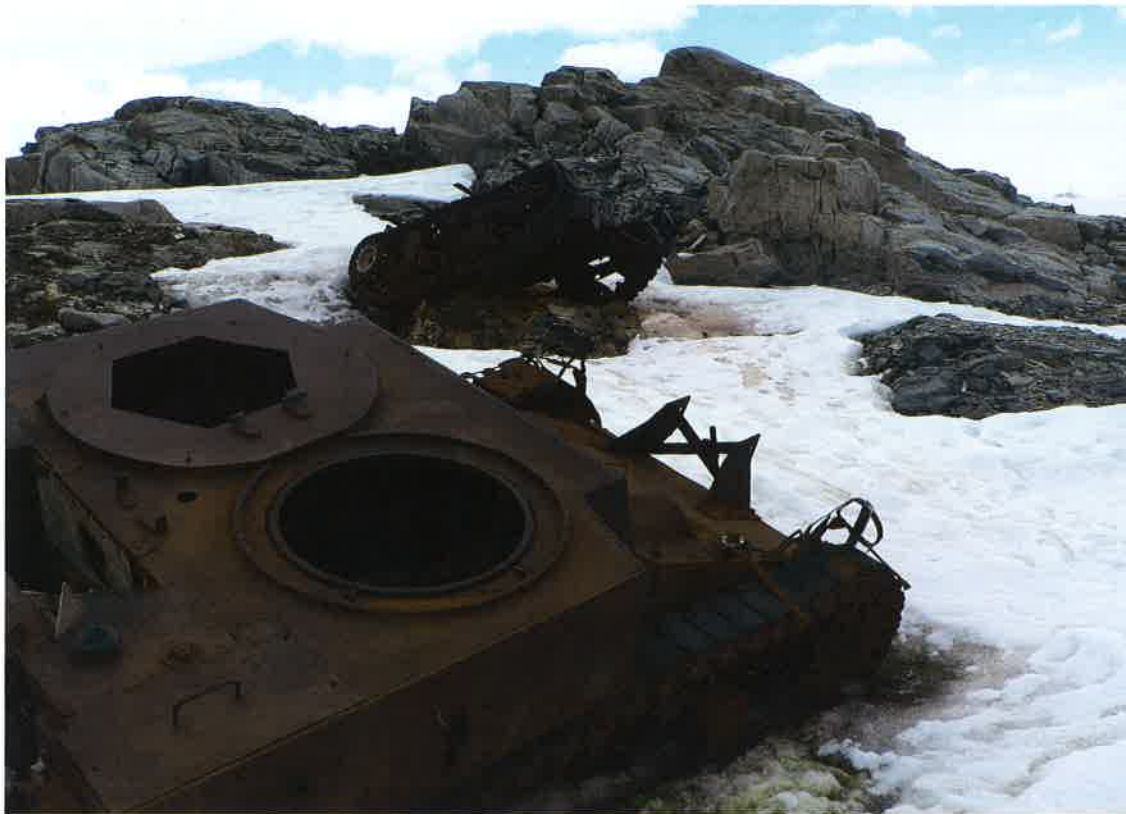
Fig. 5. Stonington Island has many large artifacts remaining from the 1941 expedition including a World War I era tank with tractor (in background). Photo: Brett Arenz
