Environmental pollutants from the Scott and Shackleton expeditions during the 'Heroic Age' of Antarctic exploration

Robert A. Blanchette, Benjamin W. Held, and Joel A. Jurgens

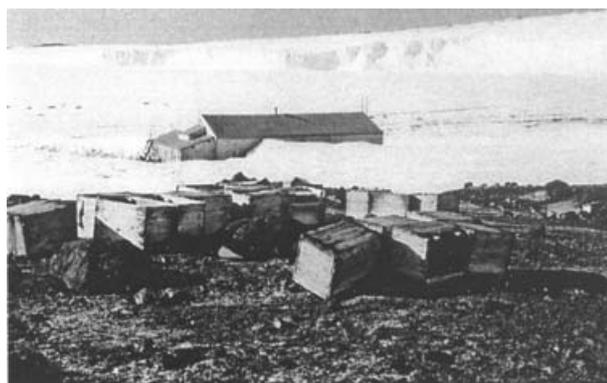
Soil samples taken adjacent to historic petroleum containers and at 1- and 2-m intervals in two fuel depots located at Cape Evans hut (Figs 1 and 2) show that petroleum products have spilled or leaked from containers and have contaminated the area. At the lower fuel depot, high levels of total petroleum hydrocarbons were present adjacent to the containers from the soil surface to a depth of 15 cm, where the ice-cemented zone was located (Table 1). The contamination was also found at the soil surface and at a 5-cm depth located 1 m from the containers. A similar set of samples taken from the upper fuel depot immediately adjacent to the fuel boxes and at 1- and 2-m intervals showed that total petroleum hydrocarbons for C₇–C₉, and C₁₀–C₁₄ were below the detectable limit. However, at the 5–10 cm depth soil sample, taken adjacent to the fuel container and just above the ice-cemented layer, 600 mg kg⁻¹ of C₁₅–C₃₆ compounds were present. All other soil samples taken away from the fuel containers at this depot had levels of hydrocarbons below the detectable limit. For both fuel depot sites, no attempt was made during this sampling to dig below the ice-cemented layer nor to move any of the containers since this would have resulted in excessive disturbance of the site. There appear to be few low molecular weight hydrocarbons present in these samples from the various locations tested (Table 1). The residual total petroleum hydrocarbons present at the site were unresolved complex material. Over the past decades these low molecular weight compounds may have been evaporated, leached, or transported out of the area. Since this is one of the oldest petroleum spills in Antarctica and the compounds have been in the soil for more than nine decades, some degradation by soil microbes could also have taken place. The high molecular weight compounds present in

Fig. 1. Fuel depot at Cape Evans near the historic hut. High concentrations of polyaromatic hydrocarbons are in soils below and around the fuel containers.

1. Petroleum spills. Large concentrations of polyaromatic compounds, many of which are known carcinogens, have spilled into the soils at the historic fuel depot areas. At the lower depot, the contaminants are present immediately below and around the containers and the contamination extends up to 1 m away. In the upper fuel depot, the contaminants appear restricted to the area immediately under and adjacent to the containers. The Protocol for Environmental Protection to the Antarctic Treaty (1991), in Annex III, Article 1, indicates that past and present waste-disposal sites on land and abandoned work sites of Antarctic activities shall be cleaned up by the generator of such wastes and the user of such sites. However, this does not include removal of any structure designated as a historic site or monument or the removal of any waste material in circumstances where the removal would result in greater adverse environmental impact than leaving waste material in its existing location. It appears appropriate that all containers should be emptied of their petroleum materials so that continued release of polyaromatic compounds into the environment does not occur. Since the levels of contamination in the soil exceeds current standards used to determine if clean-up is required at sites where petroleum spills have taken place, one method of control would be to remove the contaminated soil under and around the fuel boxes and transport it out of Antarctica for remedial treatment. The historic site, however, contains numerous artifacts on the ground and in the top layers of the gravel, and excavation and removal of the contaminated soil would need to be done under the supervision and guidance of an archaeologist. Disturbance of the historic site with its rich cultural heritage is of great concern, and drastic measures, such as the removal of large quantities of soil, need careful consideration. Additional studies are needed to determine if the level of contamination within the historic boundaries is confined to the site and if it poses a threat to the surrounding Antarctic environment. Since this is the oldest known petroleum spill in Antarctica, the site also has potential scientific value to serve as an experimental area for studying and isolating native micro-organisms that grow in the contaminated soils and may be able to degrade

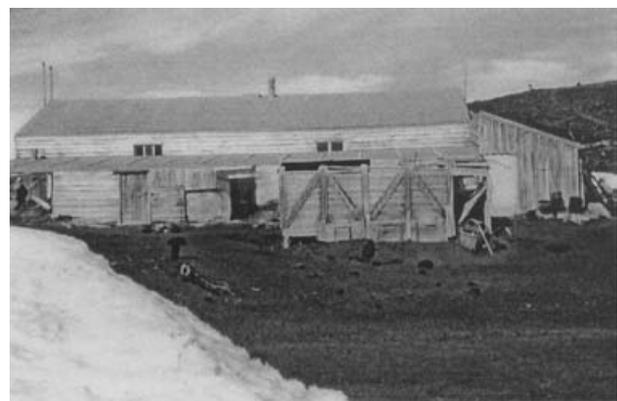
Fig. 5. Snow-free area round Cape Evans hut that contains several hundred pieces of asbestos on the surface of the ground.

2. Materials containing asbestos that litter the area around Cape Evans should be removed. Several hundred pieces larger than 1 cm² are on the surface of the ground in the snow-free areas around the hut. These materials continue to be fragmented and abraded as visitors to the site walk around the hut. It is not known how much additional asbestos exists under snow and ice, but as it melts the exposed asbestos should be removed. The larger pieces of asbestos can be easily collected, properly contained, and shipped out of the Antarctic for disposal. The smaller sized materials (less than 1 cm²) and materials below ground, however, will require significant effort to collect. The structure that contains the hut used for magnetic observations appears to be functioning. This structure has significant historic value and should remain at the site. Although the current wooden structure covering the hut functions very well to contain the asbestos-lined hut, Antarctica's severe weather is taking its toll on the wood (Blanchette and others 2002). Wind and salt will continually erode the plywood used in the building causing it to delaminate and deteriorate. This structure must be maintained and upgraded in the near future. A more stable and permanent containment building will be needed to insure that the large amount of asbestos in this historic hut remains confined to the building. A structure that can withstand severe storms (and possibly allow visitors to view the magnetic hut through Plexiglass or other similar material) is needed to prevent the possibility of an extremely large amount of asbestos material being broadcast into the environment should the containment structure be destroyed by katabatic winds or other extreme weather conditions.

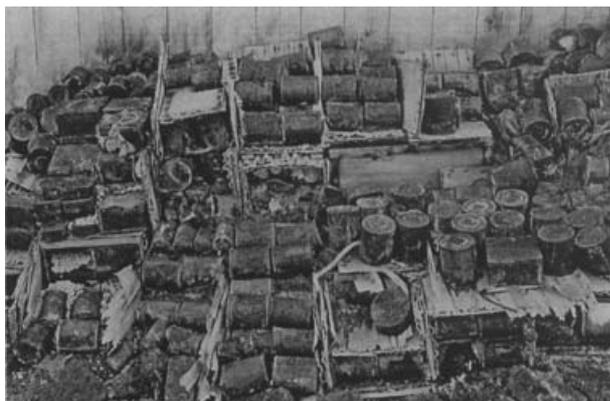
Fig. 6. Deteriorating cans and wooden crates of food stores left at the Cape Royds hut.

outside of the hut, and around the Cape Evans hut (Fig. 6). Many of the soils near these materials had concentrations of up to 1620 ppm lead (Table 4). In samples taken from soils without storage crates or deteriorated canned goods nearby (Table 4: sample taken from the north corner of Cape Evans hut), concentrations were only 7 ppm.

3. The presence of heavy metals around the hut from lead-deteriorated paint is localized to a few areas immediately adjacent to the *Discovery* hut. A greater concern is the heavy metals that appear associated with the deteriorated canned goods around the Cape Royds and Cape Evans huts. As more of the canned goods stored at the huts continue to deteriorate, additional metal ions will be released into the soil. The movement and distribution of these heavy metals into the Antarctic environment should be studied to determine if any potential hazards could develop. The lead/zinc flashing materials that are at the site should be removed to avoid future weathering and release of additional metal ions into the soil. The historic woods that currently have increased levels of lead pose no problems, but locations should be noted when future restoration work is done. High concentrations of chromium and lead exist in woods affected by the chemical spill inside the Cape Evans hut. Access to this area should also be restricted to avoid the fragile defibrated wood being disturbed and possibly dispersed within the hut. Since the caustic substance is still in the wood and deterioration is likely to be continuing, these areas need special conservation efforts to remove the toxic substances from the wood and consolidate the affected woods.

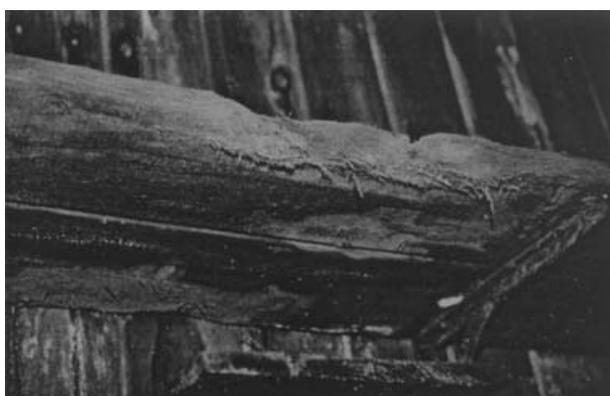
Fig. 7. Chemical spill inside the Cape Evans hut causing a deterioration of the wood. High concentrations of chromium and lead are associated with this caustic chemical spill.

A very unusual type of wood deterioration was found within the Cape Evans hut affecting the shelves, wall, and table at the east end of the hut used by the expedition crew as a science laboratory (Fig. 7). Affected wood has been extensively defibrated, changing the normal structure of the wood to masses of brown fibrous material. Elemental analyses of this deteriorated wood showed high levels of copper, chromium, iron, and lead, suggesting that a caustic chemical spill had occurred. The chemicals were absorbed into the wood and have caused a destructive dissolution of the wood cell structure. This type of deterioration appears similar to advanced stages of attack observed by salts and other chemicals to wood (Blanchette and others 1991, 2002) where the lignified intercellular regions of the woody cell walls have been degraded. The deteriorated wood is also similar to degraded wood found in the historic

laboratory of Thomas Edison, which apparently was affected by a similar type of chemical spill (Blanchette and others 1991). The chemicals caused a slow degradation of wood, and the process was allowed to continue unchecked because the laboratory is a protected historic building. In the Antarctic, the chemicals absorbed by the wood have had many decades to corrode and alter the cellular structure resulting in the current condition of the wood.

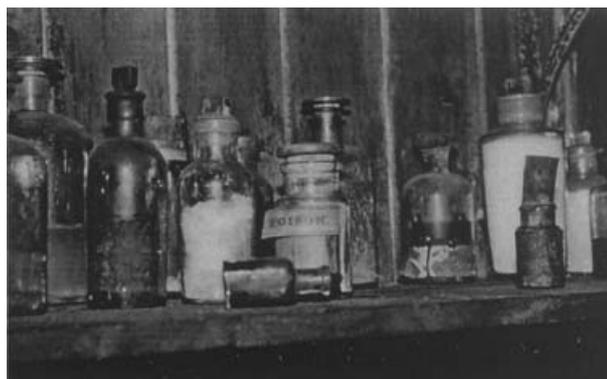
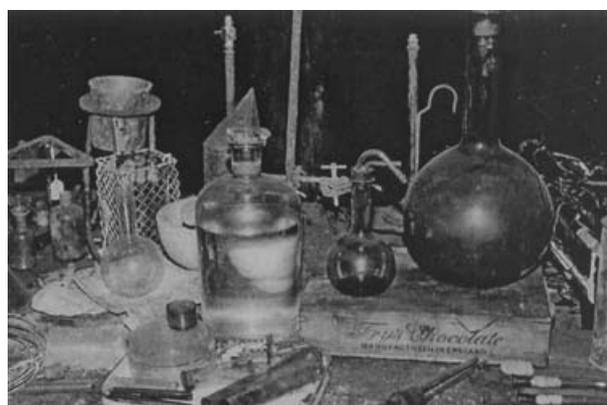
Fig. 8. Bottles of chemicals on shelf in the Cape Evans hut. Most labels that identify the chemicals have deteriorated and cannot be read, but one labelled 'poison' remains.

Fig. 9. Many chemicals are still present in the Cape Evans hut, associated with the scientific apparatus left behind by the early explorers.

There are many chemicals in various unlabelled bottles, containers, and glass tubes or other scientific apparatus left within Cape Evans hut that should be evaluated to ascertain their identity (Figs 8 and 9). The high relative humidity found within the huts (authors, unpublished data) has promoted mold growth on paper, textiles, and even wood. These organisms have contributed to the poor condition of many of the labels on the chemical bottles and containers, and most have deteriorated. In the past, conservators from the Antarctic Heritage Trust have catalogued labelled chemical bottles in the historic huts, but many unknown substances remain. Chemical spills may occur by freeze-thawing of liquids and subsequent glass breakage, by inadvertent accidents

4. A review of all scientific apparatus and chemicals in the hut should be completed and toxic or hazardous materials identified. In the event of a future accidental chemical spill, materials to contain and clean up the chemicals are needed within the huts. Test tubes, flasks, and other scientific apparatus containing battery acids, caustic alkaline materials, or any hazardous material should be removed or secured to avoid any possibility of spillage and damage to the historic hut and artifacts.
