Environmental factors influencing microbial growth inside the historic expedition huts of Ross Island, Antarctica

B.W. Held^{a,*}, J.A. Jurgens^a, B.E. Arenz^a, S.M. Duncan^b, R.L. Farrell^b, R.A. Blanchette^a

Abstract

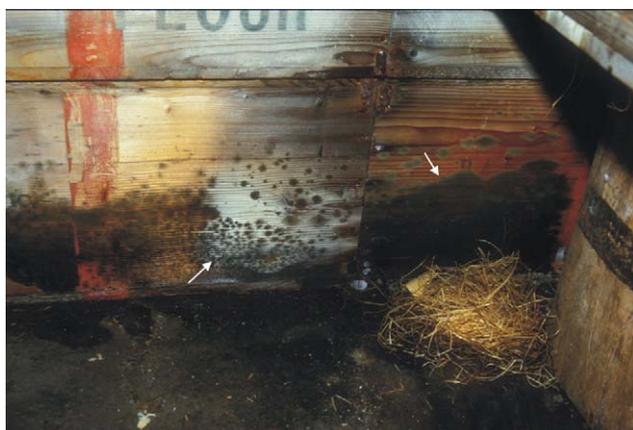
Fig. 3. Mold growth on food crates in the galley area of Cape Evans hut. The arrow on the right points to a large area of fungal growth and the arrow on the left points to scattered colonies of fungi.

Isolations were made from swabs taken from wood surfaces in the galley area of the hut where extensive mold growth was found. The fungi identified are listed in Table 1. The sequence from one particular fungus that was isolated infrequently did not match well with any presently in GenBank, and has remained unidentified. Mold growth was visually evident on a number of artifacts made of wood, leather and textiles in several areas. In the galley, extensive mold growth was observed in areas between wooden supply crates (Fig. 3), on the legs and underside of a table and on the lower portion of the south hut wall. The affected area also extends to an area of crates adjacent to bunk beds along the south wall. Moisture in this area appears to originate from frost that occurs on the wall in the galley (Fig. 4). This is likely due to the snow and ice that accumulates on the hut exterior (Fig. 5) causing the south wall to be colder than surrounding temperature in the hut. The high RH inside the hut and the temperature differential allows condensation to occur and frost builds up on the wall. As the temperatures rise in the hut, the melting of the frost and the presumably higher RH in this area provides sufficient moisture for fungi to grow prolifically.

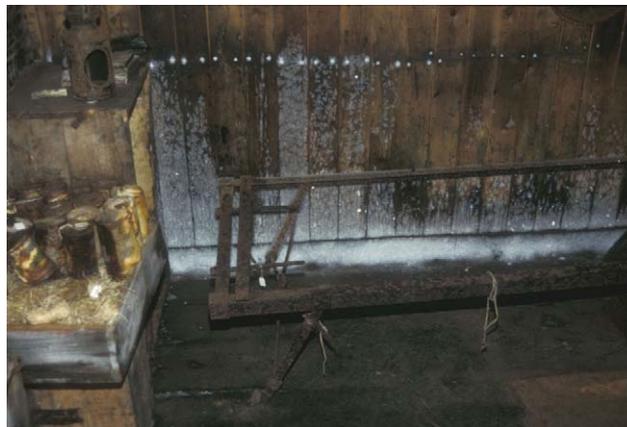
Fig. 4. Frost accumulation inside Cape Evans hut at the base of the south wall in the galley. When temperatures rise above 0°C the frost melts producing sufficient moisture for mold growth in this area.

Prolific mold growth is occurring in the Cape Evans hut where microenvironments provide favorable conditions for fungal growth. This appears to be in places where there is also a lack of air movement. In the Cape Evans hut galley area, frost accumulates where the wall

and floor join and also along the wall boards about 0.5 m from the floor (Fig. 4). Frost subsequently melts in the summer months forming free water on the surfaces of wood that provides ample moisture for fungal growth. The formation of free water also likely increases RH in this area creating a microenvironment conducive to mold growth. At present no significant decay is evident in the wood colonized by these fungi but degradation of paper, textiles and other substrates in the hut is likely occurring. *Cadophora* and *Cladosporium* species have the capacity to attack wood and other substrates and have been shown to cause a soft rot form of wood decay (Blanchette et al., 2004; Zabel et al., 1982). Continued growth of these fungi in the huts will undoubtedly result in significant damage over time.
