Microbes Can Damage but Also Help Restore Artifacts

Despite damaging wood and stone artifacts in diverse settings, microbes also may be used to restore damaged items

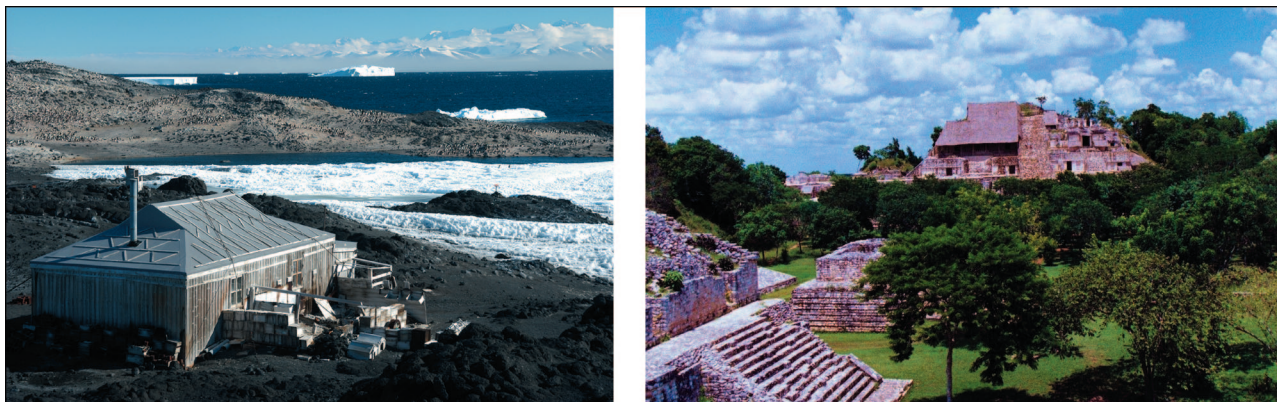
FIGURE 1

Areas of study. Left: Shackleton's hut at Cape Royds, Ross Island, Antarctica. Right: the Mayan city of Ek' Balam, Yucatan, Mexico.

From the prefabricated wooden huts of Antarctic explorers in the early 20th century to the enduring limestone ruins of the Mayan city Ek' Balam (Black Jaguar) built more than 1,200 years ago (Fig. 1), conservators, archaeologists, and other specialists are striving to understand and combat the physical, chemical, and biological processes responsible for the deterioration of these historic structures and artifacts. Each of these sites represents a cultural trove, one as a testament to a lost civilization and the other as a tribute to a bygone era of exploration. Separated by more than 10,000 km and residing in two very different climates, these sites were constructed of drastically different materials. Yet the artifacts at each location are slowly wasting away, presenting two very different cases of

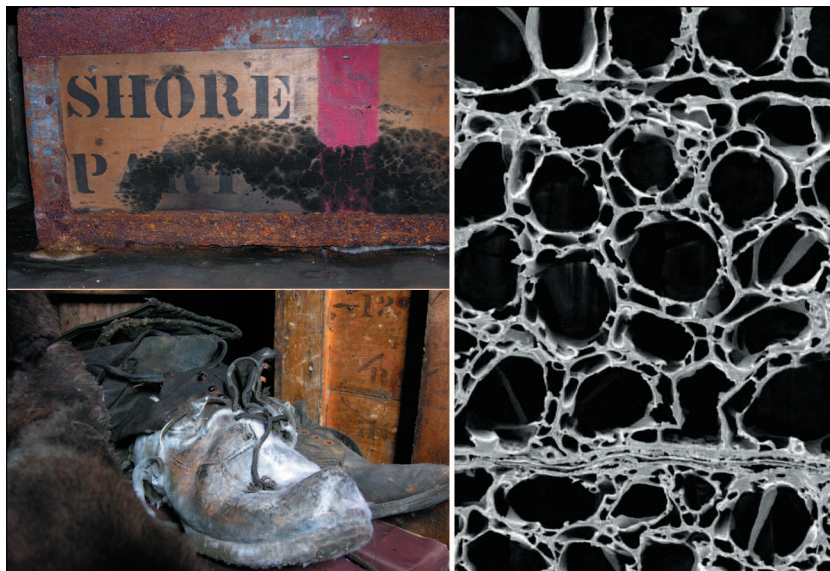
FIGURE 2

Biodeterioration of cultural properties from Scott's Cape Evans hut. Left: mold growing on a historic crate (top) and explorer's boot (bottom). Right: Wood decay cross section from Shackleton's Cape Royds hut showing extensive cavities in wood cell walls. (Figure by Benjamin Held, University of Minnesota).

Investigations of these historic sites reveal decay in the exterior woods, and blooms of fungi on the surfaces of the wood, textiles, paper, and other artifacts inside the huts (Fig. 2). The decay in these huts is not the type usually encountered in temperate and tropical zones, where wood-destroying basidiomycetes are prevalent. Instead, the ascomycete *Cadophora* is the predominant species causing soft rot by producing cavities inside wood cell walls (Fig. 2). This poorly known group of fungi appears to be common in Antarctica, where they live in soils and utilize varied carbon sources. Although it has taken decades of relatively slow growth during the short Austral summers, their cumulative damage to historic wood and other artifacts is substantial, posing serious conservation problems not only in the Antarctic huts but also throughout the world.

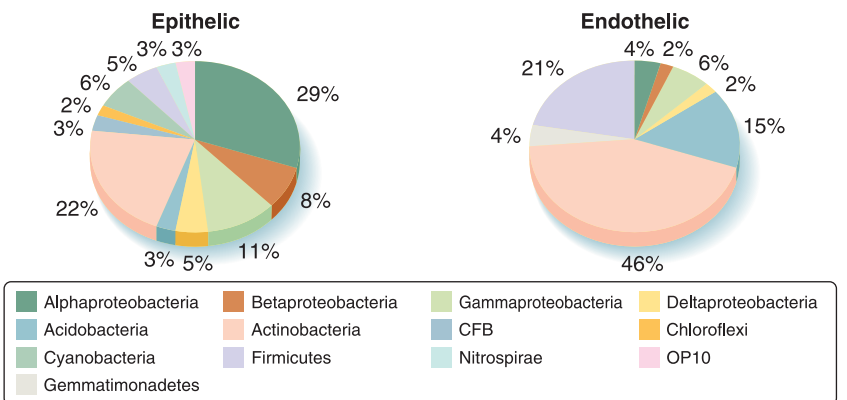
FIGURE 3

Top: comparison of epilithic and endolithic bacteria. Percentage of clones in each phylogenetic group from epilithic bacteria (left) and endolithic bacteria (right). Bottom: Ca²⁺ concentration in uninoculated flasks and flasks inoculated with endolithic bacteria.

discovered that the 16S rDNA diversity of endolithic bacteria residing 1–2 cm below the surface of limestone differs dramatically from the epilithic microflora residing above it. *Actinobacteria* dominate this endolithic community, which also contains large numbers of *Acidobacteria* and *Firmicutes* (Fig. 3).

Endolithic microorganisms may also accelerate stone-damaging chemical processes. For instance, bacteria can increase the mineral dissolution rate of the limestone in which they reside by producing simple acids. Indeed, in the presence of the endolithic bacteria, limestone releases Ca^{2+} twice as fast as when those bacteria are not added to the mix (Fig. 3).
