2.2 *In-situ* Monitoring and Stabilisation of the *James Matthews* Shipwreck Site

In the last few years, the *James Matthews*, wrecked in 1841 on Woodman Point, south of Fremantle, Western Australia has been identified as being under considerable threat from increased site exposure due to natural near-shore sedimentary processes and industrial activity in the immediate area. In 2000, an extensive on-site conservation survey was carried out to establish the state of preservation of the wreck. In 2003 it was confirmed that further exposure of the site was occurring at an alarming rate and devising a suitable *in-situ* management plan, including an extensive conservation monitoring programme was of paramount importance. A number of different reburial techniques are currently being evaluated and geological, physico-chemical and microbiological changes in the burial environment monitored over time. The results of these experiments will assist in implementing the most appropriate mitigation strategy for the long-term preservation of this wreck site.

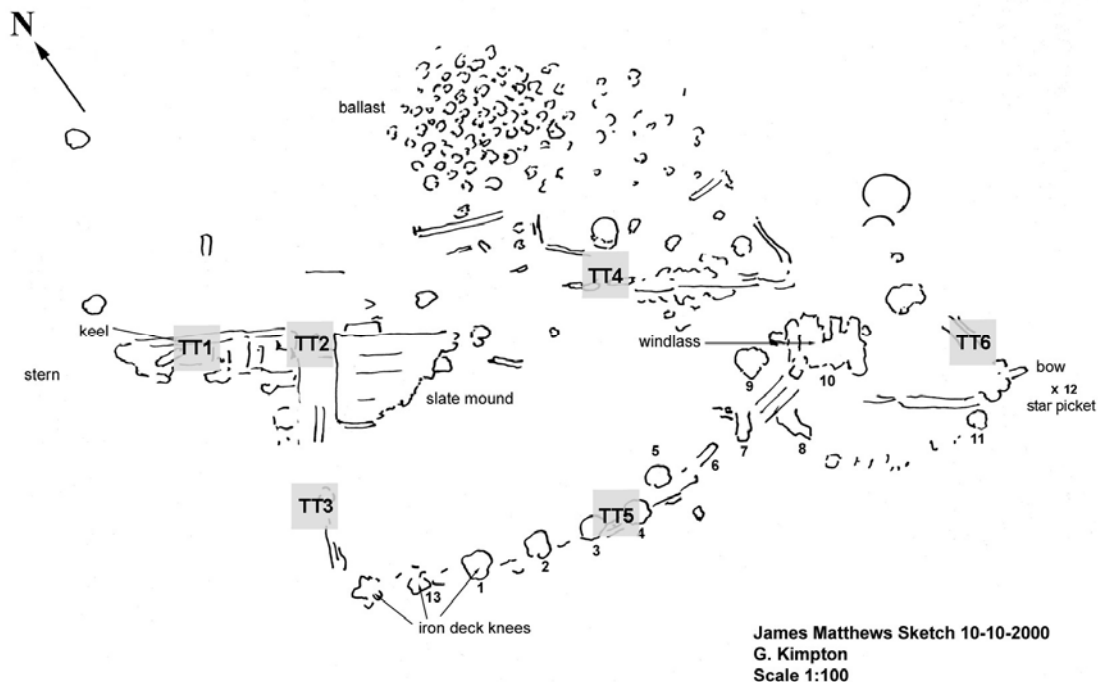
Figure 2. Sketch plan of the James Matthews wreck site indicating the extent of site exposure in 2000 and the position of the test trenches.

A visit to the site in early 2000 however, indicated that there had been extensive scouring and exposure of the vessel remains and therefore, from August to December 2000, a comprehensive on-site conservation survey was conducted with a primary objective to recover the hull remains for stabilisation and eventual display. It involved a limited excavation of the site, which consisted of dredging six 2m³ test trenches (TT) at various positions on the site (Figure 2). The survey included a full corrosion survey of the iron fittings on the starboard side of the wreck, pH profiles, maximum water contents (U_{max}) and wood species identification of the structural timbers located in each test trench and physico-chemical and microbiological analyses of the surrounding sediments. The survey results are published in full in Heldtberg et al. (2004) and Godfrey et al. (2005) but basically, the results of the survey showed that the site had been previously exposed to a depth of ~30cm for an extended period of time, the exposed timbers exhibited active and extensive marine borer damage whilst the timbers buried to a depth greater than 30cm were in good condition. As the majority of the structural hull remains were buried it was concluded that the vessel could be recovered, however the estimated cost of recovery and conservation was prohibitive (in excess of 450M €) and hence, the idea was abandoned. Remediation of the exposed wreck site however, still needed to be addressed. The results from the survey by design, also provided important information on the physico-chemical and biological nature of the environment prior to the implementation of any mitigation strategy.

The results from the analyses (pH profiles, U_{max}) of the timbers in test trench 2 (Figure 2) (Godfrey et al. 2005) conducted during the inaugural 2000 conservation survey prior to the deposition of any sand bags were used as a baseline comparison for subsequent analyses (pH profiles, U_{max}) carried out in 2003 after stabilisation with canvas sand bags since April 2001 and in 2005 (U_{max} , microscopic analysis), after coverage with UV stabilised reinforced polymeric sand bags for one year. The positions of the measured structural timbers in test trench 2 are shown in Figure 8. All timbers were white oak with the exception of the outer planking 2 which was elm. The approximate dimensions of the major structural timbers measured on-site were as follows: frames (18cm wide x 12cm thick), outer planking (25 x 5cm), inner planking (20 x 4cm) and the keelson (33 x 20cm).

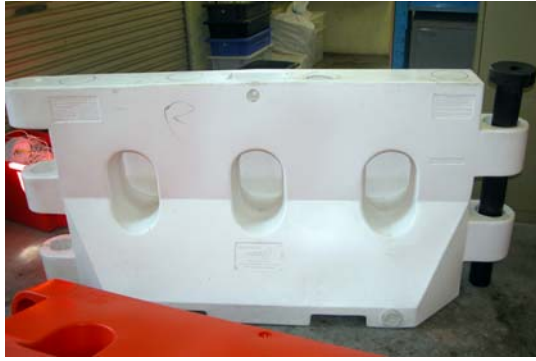
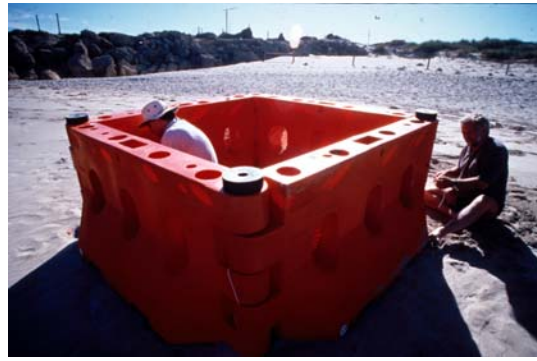
Figure 3. a) Crash barrier unit with enclosed holes; b) Example of assembled crash barrier units prior to experimental deployment.

In March 2003, a field trial of the 'test square' (Figure 3b) was initiated on another shipwreck site subjected to greater wave loading than the *James Matthews* to assess the logistics of deployment, stability of the structure, the effect on the local seabed topography and sediment movement within the barrier arrangement. After two years this approach, after some modifications, had shown the concept to be effective. The results of this study are presented in Winton & Richards (2005) and demonstrated that the road crash barrier arrangement was structurally very stable, could withstand short period wave loading, did not result in significant changes to the local seabed topography and with a shade cloth covering on the backfilled sediment inside the test square, maintained this depth of sand coverage over time. Therefore, in early 2005, based on the success of the pilot study, another 'test square' was placed adjacent to the *James Matthews* wreck site. The usual sediment and seabed response is being monitored within and around the test square with changes in the micro-environment (i.e. dissolved oxygen, redox potential, pH, total sulphide, nutrient levels, biological activity) of the sediment inside the test square monitored at regular intervals.

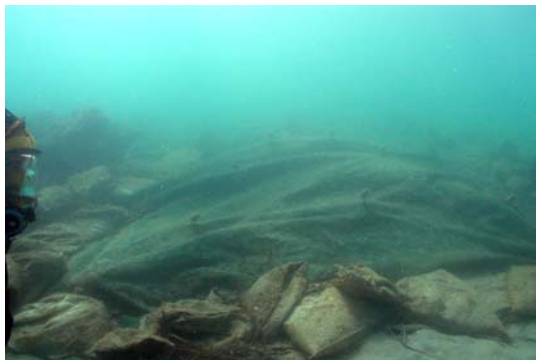
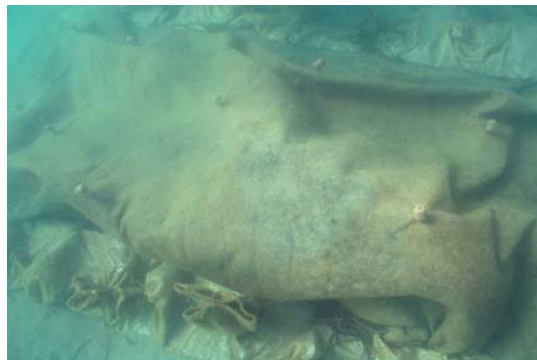
Figure 4. a) Shade cloth mat on bow in-situ; b) Shade cloth mat off site in-situ.

Although the result of this experiment was essentially negative, observing the reducing environment under the shade cloth was encouraging. Therefore two more shade cloth mats were redeployed in early 2005: one on the bow section (Figure 4a) and the other adjacent to the wreck, 20m off site (Figure 4b); with some simple modifications: small fishing buoys were attached to keep the shade cloth suspended in the water column and concreted fittings in the bow area were covered in sandbags to minimise damage to the cloth. Increasing the density of the shade cloth (80%) was considered in order to decrease the failure rate of the weave over time but based on the results of the 2000 conservation survey the sediment in this area is medium to coarse grain (average 700μ) calcareous sand and therefore, it was decided to continue to use the cloth with a mesh size closest to the average particle size of this sediment.

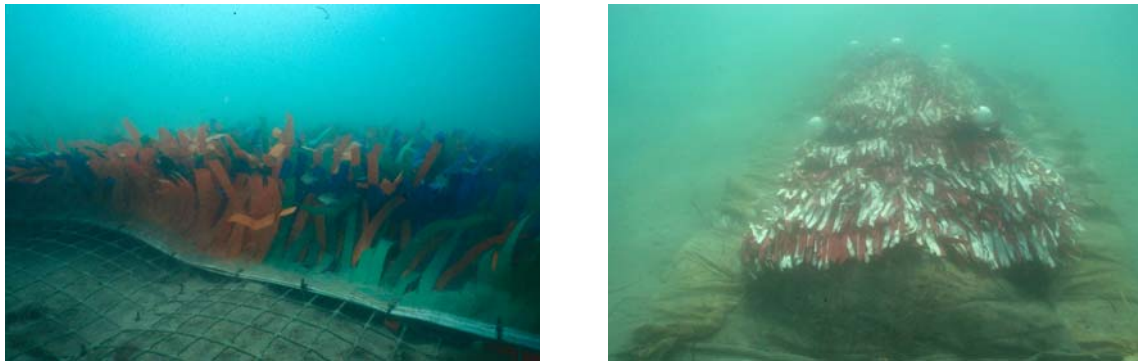
Figure 5. a) Artificial seagrass mat in-situ; b) Artificial seagrass attached to shade cloth mat in-situ.

At the same time, two other types of mats were trialled. One was an artificial seagrass mat using polyvinyl chloride bunting to simulate the natural seagrass leaves (Figure 5a) and the other utilised the same bunting material attached to the 50% density shade cloth mentioned above (Figure 5b). All materials used to manufacture the mats were polymeric in nature and UV stabilised polymeric sandbags were used to anchor the mats to the seabed. A monitoring programme similar to that being used to measure changes in seabed response and micro-environment for the test square has also been implemented.

The seagrass mat was anchored flush with the seabed surface (Figure 5a). After three months, there was extensive algal growth on the fronds but they maintained enough buoyancy to allow free movement in the water column. There were appreciable quantities of dead seagrass trapped under the mat but no notable sediment accretion (Figure 17a). There was also some toe scouring around the NE edge of the mat. After two years, the amount of colonisation on the fronds increased significantly and this added weight interfered with the movement of the fronds in the water column. There was more dead seagrass present and extensive scouring had occurred under the centre of the mat (Figure 17b).

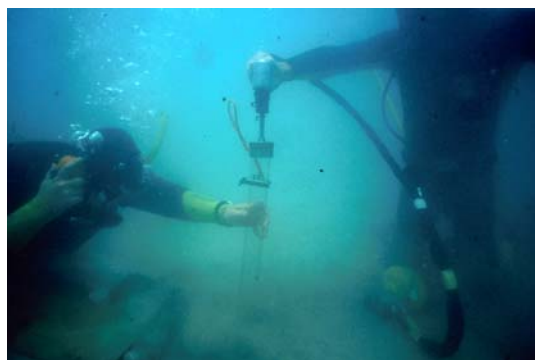
Figure 6. Polycarbonate sediment corer with hammer chisel and attachment.

A set of five sediment core samples [clear, polycarbonate (PC) cylinders (50mm diameter) 30 or 60cm in length] were collected from under each of the experimental mats [*bow shade cloth mat* (5 x 30cm); *seagrass mat* (5 x 30cm); *shade cloth mat* (5 x 30cm) and the *test square* (5 x 60cm)]. One set of reference core samples were collected 20m north-west of the stern section (5 x 60cm). The corers were mechanically pushed into the sediment column using a pneumatic hammer chisel powered by a SCUBA tank with a specially designed attachment that fitted over the PC corer (Figure 6) until the top of the corer was level with the seabed. The top of the corer was sealed with a tight fitting rubber bung. The corer was slowly withdrawn from the sediment assisted by a muffler clamp attached to the top of the sample tube until the base of the corer breached the sediment surface then simultaneously the top bung was removed whilst the bottom bung was pushed rapidly and firmly into the base of the corer. The top bung was then replaced. The removal of the top bung released the vacuum in the corer and minimised, but did not always totally alleviate, upwelling of bulk seawater through the sediment from the base of the core. The cores were stored vertically on-site in a specifically designed crate until transferred to the support vessel.

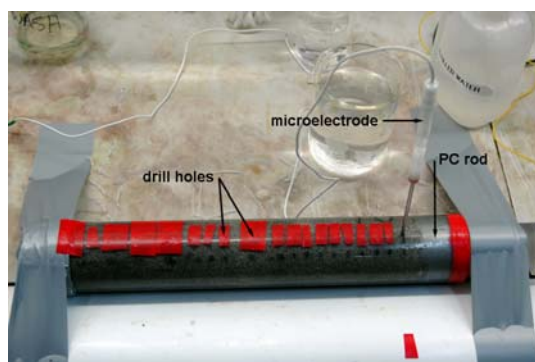
Figure 7. Example of the procedure for microelectrode measurement of the sediment cores.

One sediment core sample [PC cylinder (50mm diameter) 30 or 60cm in length] was collected from under each of the experimental mats (30cm) and from within the test square (60cm). Two separate reference core samples (60cm) were collected 20m north-west of the stern section and 20m south-west of deck knee 1 (Figure 2). The sampling procedure is outlined above. The cores were transferred to the WA Museum where they were stored vertically at 4°C up to a maximum of 5 days prior to analysis. Prior to measurement the residual seawater in the head space of the sample tubes was displaced by pressing a machined PC rod of slightly smaller diameter into the corer until the surface of the sediment was reached. An o-ring, which was fitted around its circumference, was then pressed into the junction between the rod and the corer and sealed with electrical tape. This prevented any lateral movement of sediment when the core was mounted horizontally and fixed to the bench with electrical tape prior to measurement. Holes (3.5mm in diameter) were then drilled into the PC sample tube at 1cm intervals for the first 10cm, then every 5cm until the nearest 5cm interval was reached near the base of the cylinder followed by 1cm intervals until the end of the sediment core. After each hole was drilled it was sealed with a piece of electrical tape to prevent leakage of pore water. This tape was then removed and in the following order: pH, dissolved oxygen content, sulphide and redox potential were measured using the appropriate microelectrodes (Figure 7). After each measurement, the microelectrodes were inspected under a magnifying glass and any superfluous material removed with a wetted cotton bud, then rinsed with deionised water.

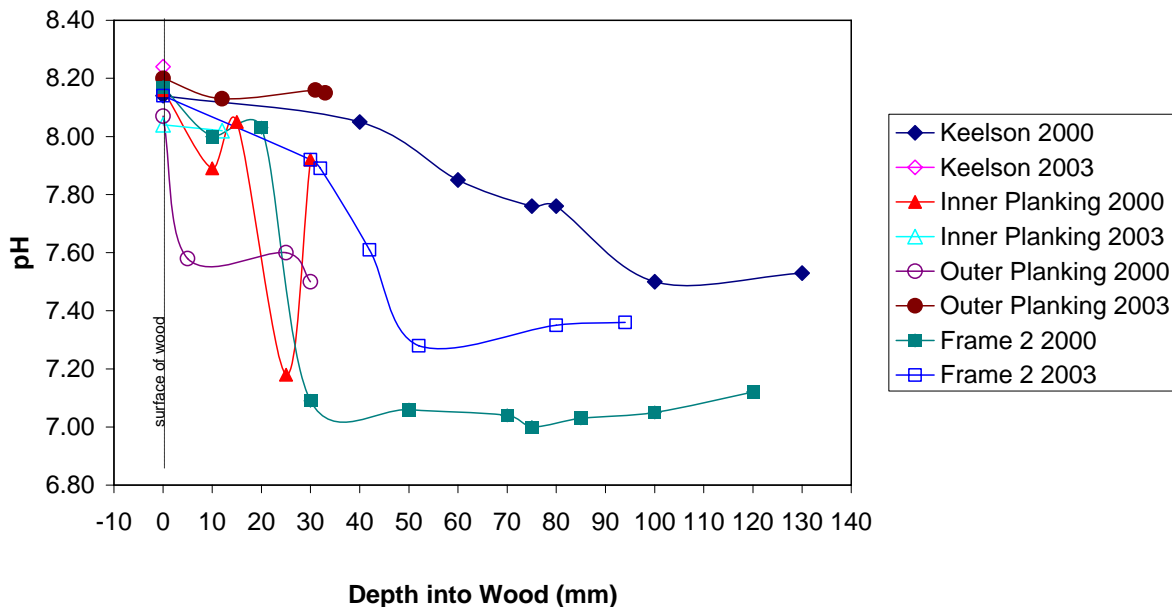
The pH profiles of the timbers measured in 2000 (solid points in Figure 9) followed a typical sigmoidal relationship. That is, the pH of the wood near the upper, more exposed surfaces was high then as the timbers were vertically traversed there was a decrease in pH that tended to plateau with increasing depth. The normally acidic nature of undegraded waterlogged wood, albeit more alkaline than undegraded, seasoned wood of the same species, becomes progressively more alkaline with increasing degradation due to the inward diffusion of alkaline seawater into the void spaces of the more degraded wood cells. Therefore, the higher pH values generally observed near the timber surfaces denoted the areas of greater deterioration.

The decreasing trend in pH as the core depth increased was indicative of a gradual decrease in the extent of degradation towards the interior of the timbers until the pH reached a minimum that represented the area of least deterioration.

Figure 9. pH profiles of structural timbers measured in test trench 2.

In comparison, the pHs of the timbers measured in 2003 (outlined points in (Figure 9) increased considerably indicating a significant increase in the extent of deterioration of all timbers in test trench 2 since the initial conservation survey in 2000. This is not surprising as most of the timbers, with the exception of the outer planking, were essentially exposed or were only covered with relatively thin layers of sediment until 2004. For example, by 2003 the keelson and inner planking were so degraded by marine borers that after the initial surface measurements, the timbers disintegrated and no further measurements could be obtained. The extent of deterioration of the outer surface of the frame had increased from 2cm to 5cm then the pH decreased to an average of 7.33 ± 0.04 compared to 7.06 ± 0.04 in 2000 indicative of a general increase in degradation. The outer planking was degraded relatively uniformly throughout its entire width indicated by an average pH of 8.16 ± 0.03 . This is interesting in the fact that this timber was almost always covered with sediment, however obviously the oxygen concentration in the sand layer was not low enough to prevent continued degradation.

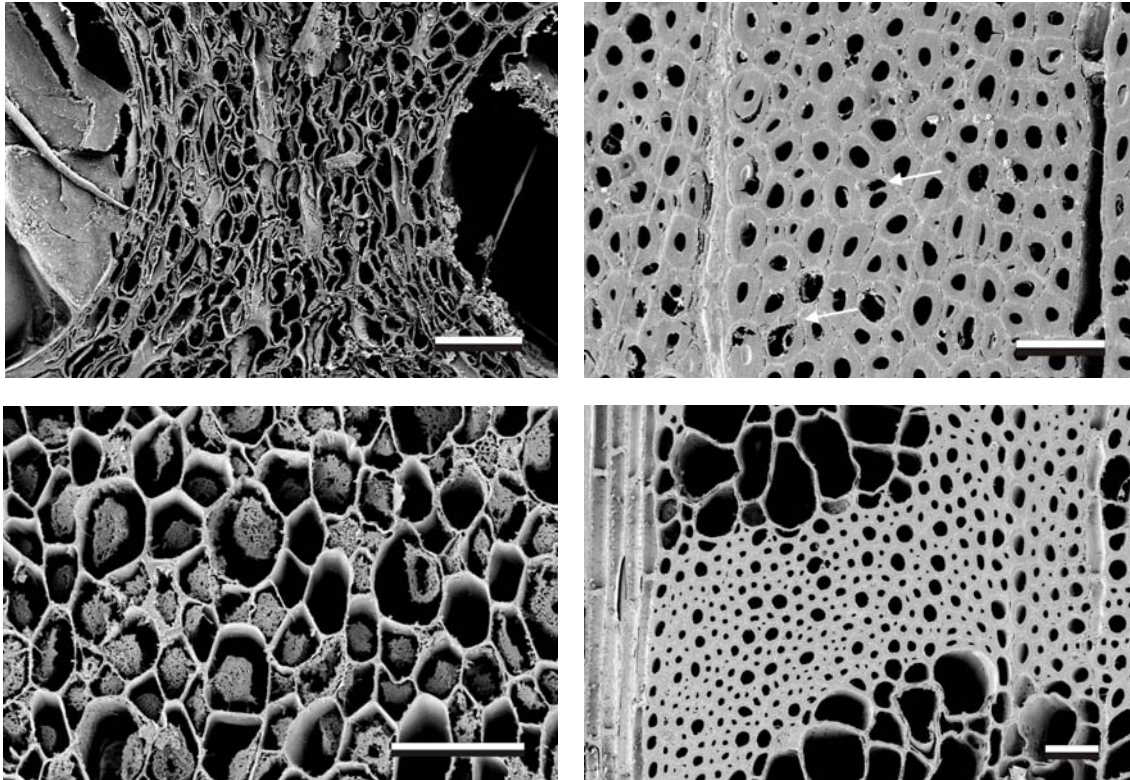
The wood samples collected from frame 2 (Figure 11a and b) and the outer planking (Figure 11c and d) showed the exterior of the samples were highly degraded while the interior zones were less deteriorated. Much of the decay observed in the exterior of frame 2 and the outer planking was due to bacterial degradation, resulting in a complete collapse of the secondary cell walls. Bacteria had made numerous

minute cavities throughout the secondary cell walls. Cellulose and hemicelluloses that predominantly make up the secondary cell walls were degraded leaving behind a loose matrix of lignified secondary wall material as well as the middle lamella between cells. The interior zone of the samples was largely free of appreciable decay. However, some fungal soft rot cavities were observed in the cell walls of this area. Due to marine fungi requiring higher oxygen concentrations for metabolic processes, this fungal attack was likely to have occurred before the wood was buried in sediment. Environmental changes that occurred as the depth of sediment increased over the years appear to have made conditions non-conducive to decay by soft rot fungi. Instead, bacterial erosion and tunnelling became the dominant forms of cell wall attack. A progression of limited soft rot followed by bacterial degradation took place over time. In the outer regions of the wood, conditions allowed extensive degradation by bacteria to occur and the soft rot attack that was once present was masked by the advanced stages of bacterial attack. Most probably, the size of the frame 2 (12cm) and the increasing depth of burial for both the frame and the outer planking over the past five years have allowed the inner regions of these timbers to remain relatively free of degradation.

Figure 11. Scanning electron micrographs of wood samples from frame 2 (top photos) and a core sample from the outer planking in test trench 2 (bottom photos) showing the condition of the wood cells. a) Upper left, Extensive bacterial degradation and complete collapse of the wood cell walls in a sample from the exterior wood surface. b) Upper right, Interior region of the wood showing a relatively intact cell wall structure. Close examination shows several isolated soft rot cavities are present in these cells (arrows). c) Lower left, Exterior wood cell walls showing extensive bacterial degradation. The secondary cell wall is severely degraded and only a matrix of eroded cell wall material is left. An intact middle lamella, which is highly lignified, remains between cells. d) Lower right, Interior wood cells showing relatively sound wood structure.

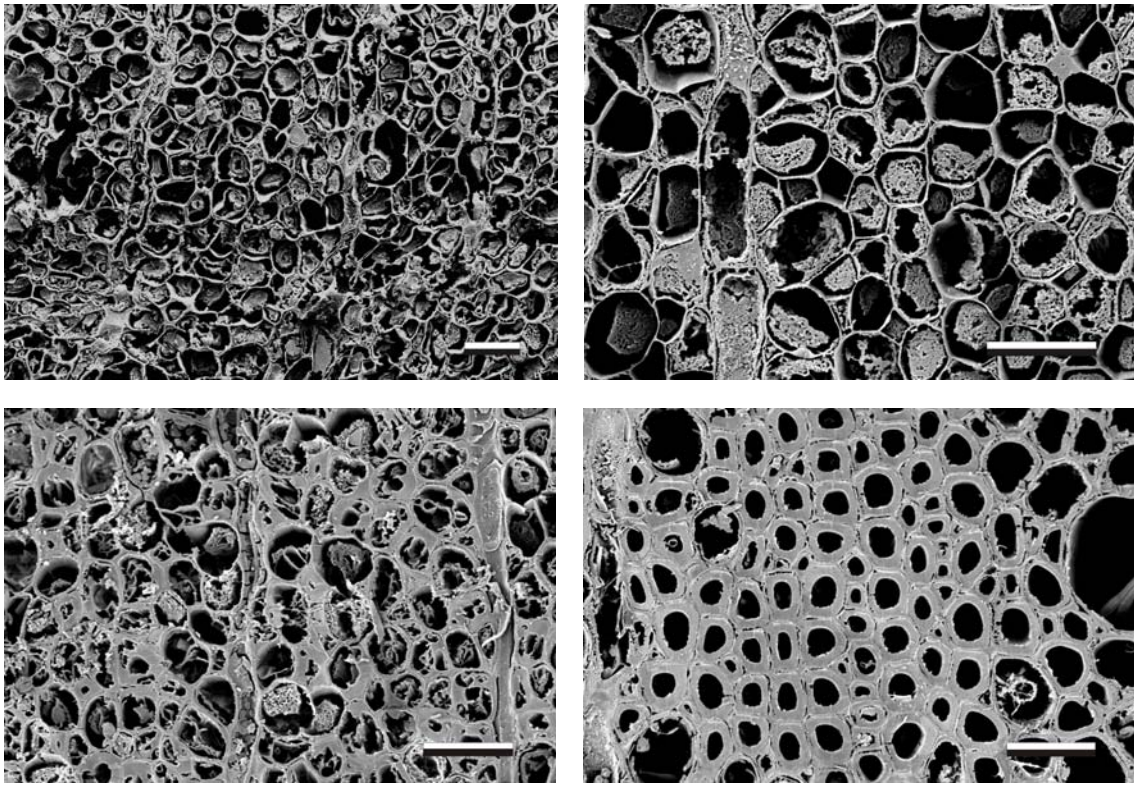
Sections from the inner planking reveal deteriorated wood cells throughout the sample (Figure 12a and b). The cell walls were heavily degraded by bacteria and large strength losses were evident. Over the past five years this timber was either totally exposed or only covered in thin layers of sediment (<1cm) and therefore, subjected to conditions conducive for wood destroying bacteria to colonize and attack this entire structural member. The keelson also showed exterior wood that was degraded more than the interior regions (Figure 12c and d). Although some bacterial degradation was seen, soft rot cavities were pronounced. The extent of exposure of this timber increased over the years and hence, it has been subjected to a more aerobic micro-environment, which allowed a greater period for soft rot to occur.

Figure 12. Scanning electron micrographs of samples taken from the inner planking (top photos) and keelson (bottom photos) from test trench 2. **a) Upper left**, Exterior wood showing attack by bacteria. The secondary wall is extensively degraded and a fragile middle lamella remains between cells. **b) Upper right**, Advanced bacterial degradation extending into the interior portion of the sample showing the advanced decay with only a matrix of degraded cell wall material left between cells. **c) Lower left**, Exterior wood of sample showing extensive soft rot and bacterial degradation. Some cell walls have soft rot cavities while others have degraded cell walls caused by bacteria. **d) Lower right**, Wood from the interior portion of the keelson sample showing relatively intact cell walls. Only a few cells show soft rot cavities or evidence of bacterial degradation.

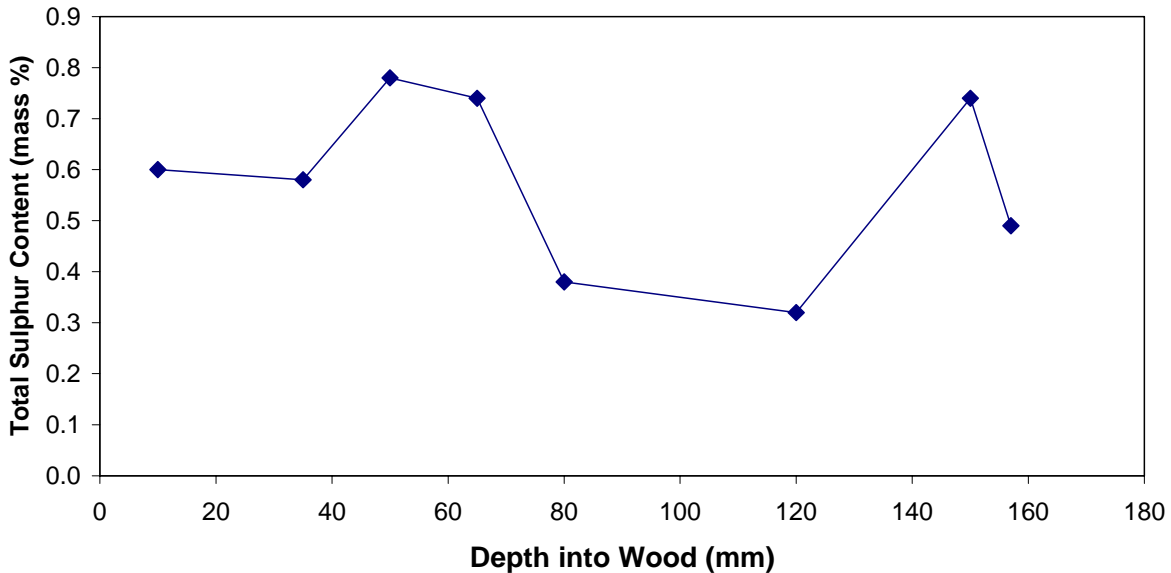
The entire core sample was found to contain intermediate sulphur concentrations ranging from 0.32 to 0.78% with an average value of $0.58 \pm 0.17\%$, with the inner regions containing less total sulphur in comparison to the exterior areas (Figure 13). The raw XANES spectra (Figure 14a and b) showed two major peaks corresponding to elemental sulphur (S_8), thiols (R-SH) and disulphides (R-S-S-R) at 2473.0eV and sulphate (SO_4^{2-}) at 2482.6eV (Sandström et al. 2003). However, the intensity maximum of the sulphate peak is approximately a factor of 3 times greater than that of elemental sulphur for the same sulphur concentration. Therefore, the spectra showed that reduced sulphur species were the dominant form, especially in the inner regions of the core sample where almost no sulphate is present because oxygen would be limited due to the

Figure 13. Depth profiles of total sulphur in frame 2.

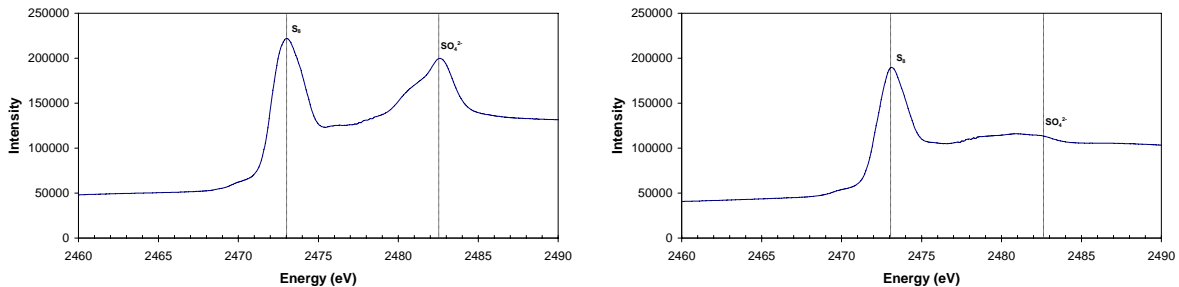
thickness of the timber (Figure 14b). On the other hand, the presence of the sulphate peak in the surface sample (0-8mm) spectrum (Figure 14a), albeit relatively small when the intensity factor difference was taken into account and the emergence of a small peak at 2481.4eV corresponding to sulphonates ($R-SO_3^-$) (Sandström et al. 2003) indicated that some oxidation of the reduced sulphur species had occurred in the upper surface of the frame when it was exposed to a more oxygenated environment. There was a very small emerging pre-peak at about 2470.5eV (Figure 14a) that was believed to be a pyrrhotite-like FeS_x phase (Sandström et al. 2002), however to reveal and distinguish this peak from the reduced sulphur peak at 2473.0eV requires careful analysis.

Figure 14. Sulphur K-edge XANES spectra from a) exterior frame 2 (0-8mm core section) and b) interior frame 2 (77-80mm core section).

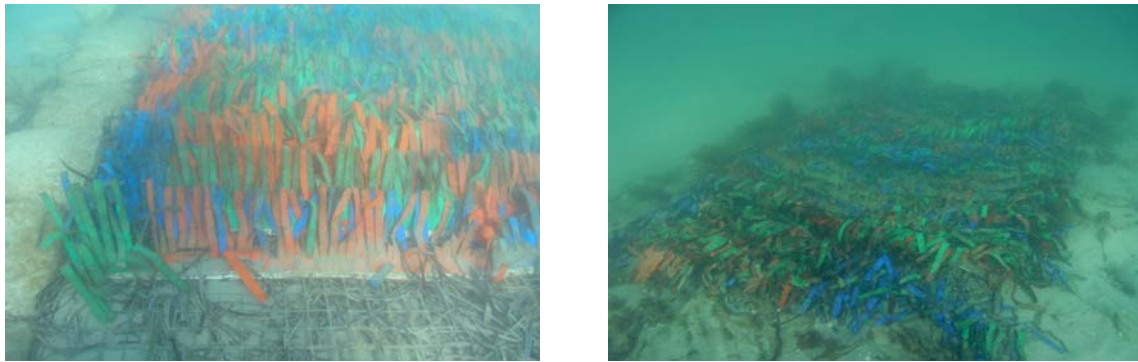
Figure 17. The artificial seagrass mat deployed off site after a) three months and b) two years.

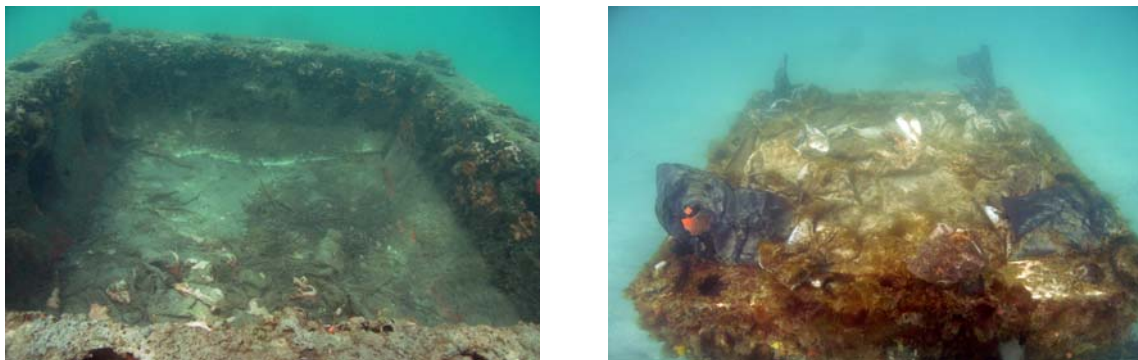
The preparation and deployment procedure for the test square has been previously described in Winton and Richards (2005). After the test square was positioned on-site in April 2005, it was backfilled with local sediment, which was then covered with shade cloth and anchored with polymeric sand bags. After three months, the depth of sediment within the confines of the test square had diminished significantly and by 2006, it was totally devoid of sand and only the shade cloth covering and the sand bags were present in the bottom of the test square (Figure 18a). It was obvious that the sediment had been leaking from the corners of the test square. The test square was refilled in May 2007, but this time prior to backfilling, heavy gauge black polyethylene sheeting was draped over the interior of each corner to prevent any sediment loss through these gaps. It is important note that the shade cloth and sand bags in the base of the test square were not removed prior to the second refilling. After three months, there was no significant change in sediment level within the confines of the test square (Figure 18b).

Figure 18. The test square after a) one year with significant sediment loss and b) three months after refilling.

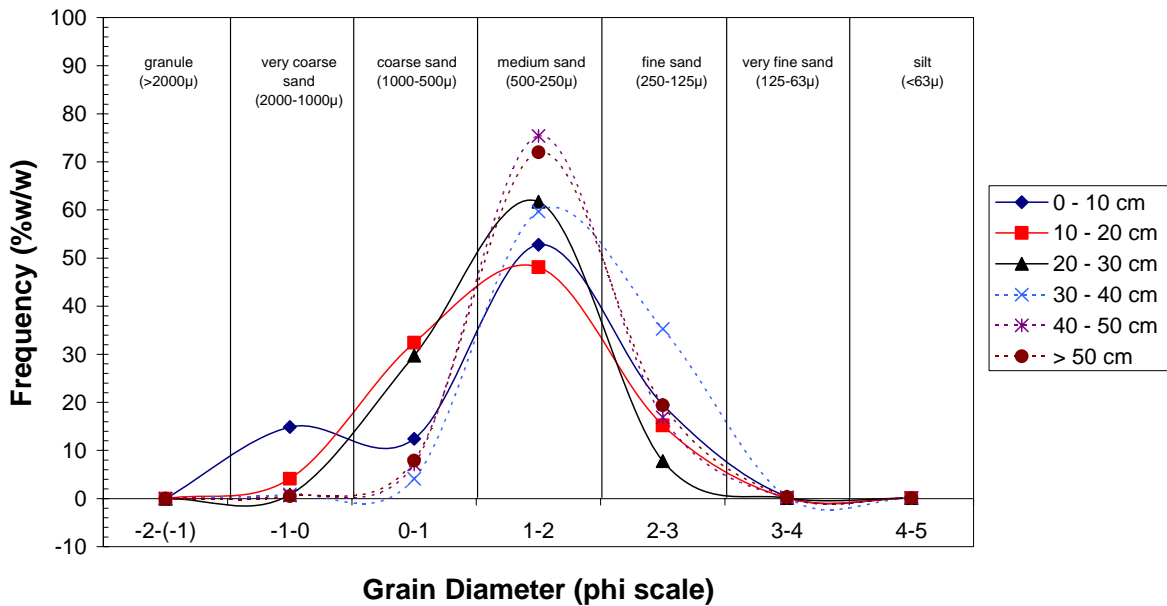
The simplest method of presenting particle size distribution data of sediments is in graphical form by means of a histogram, where $\phi = -\log_2$ of the grain size diameter (mm). These even divisions are referred to as the phi scale, where the intervals from (-1)-0 to 4-5 represent decreasing grain size intervals ranging from very coarse sand to silt, respectively (Figure 19). The results of the particle size distribution analyses for the redeposited sediments in the test square and under the experimental mats are similar, despite differences in the total length of the core samples, therefore only the histograms of the two 60cm sediment cores from baseline 20m NW and the test square will be shown as examples (Figures 19 and 20, respectively).

Figure 19. Histogram of particle size distribution of the baseline 20m NW sediment.

The sediment around the *James Matthews* site is predominantly calcareous in nature with a low siliceous content (Godfrey et al. 2005). In general, the baseline sediment consisted largely of medium (250-500µ) skeletal and detrital lithoclastic sands with some coarser grained inter-beds of predominantly skeletal grains representing gastropods and bivalves in the upper 20cm of the sediment column (Figure 19). Sorting is dependent on grain size and gives an indication of the effectiveness of the depositional medium in separating grains of different classes. The mean particle size of the baseline sediment decreased marginally with increasing sediment depth and demonstrated a trend for sorting to increase gradually from moderately well sorted to moderately well sorted as the sediment depth increased. This is consistent with sand-sized sediments, which are more easily transported and reworked by water movement. Hence, the sediments on beaches and shallow shelf areas, similar to this site, will tend to be better sorted than sediments that are deposited rapidly.

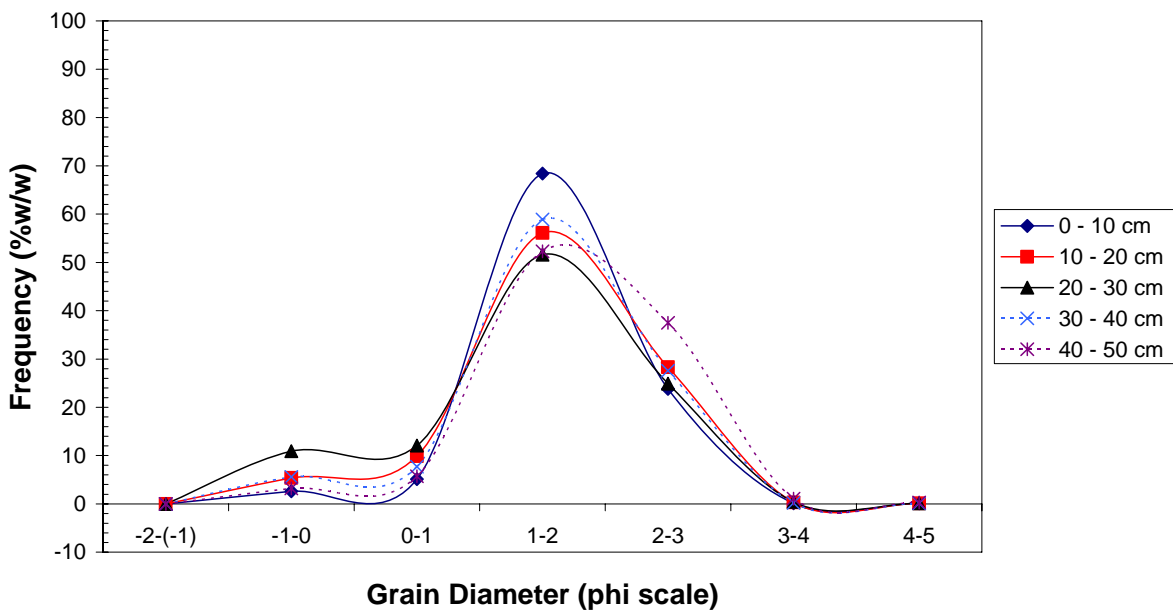
Figure 20. Histogram of particle size distribution of the test square sediment.

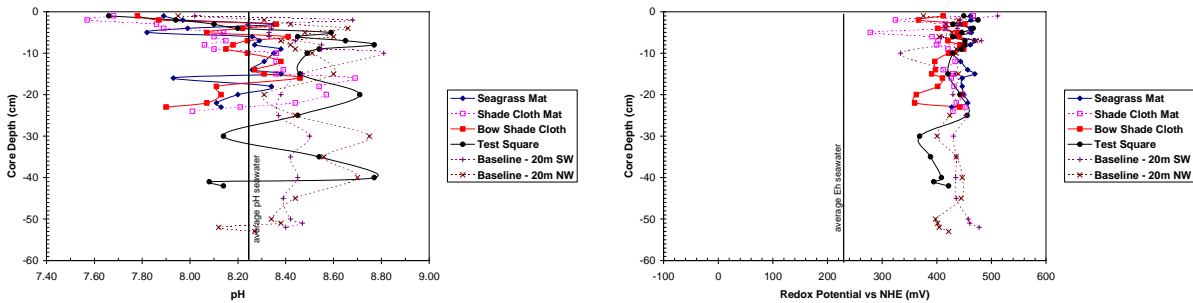
Figure 22. Profiles of a) pH and b) redox potential with increasing sediment depth.
