HISTORICAL POLAR BASES – PRESERVATION AND MANAGEMENT

NORTHUMBERLAND HOUSE, FORT CONGER AND THE PEARY HUTS IN THE CANADIAN HIGH ARCTIC: CURRENT CONDITION AND ASSESSMENT OF WOOD DETERIORATION TAKING PLACE

Robert A. Blanchette, Benjamin W. Held and Joel A. Jurgens

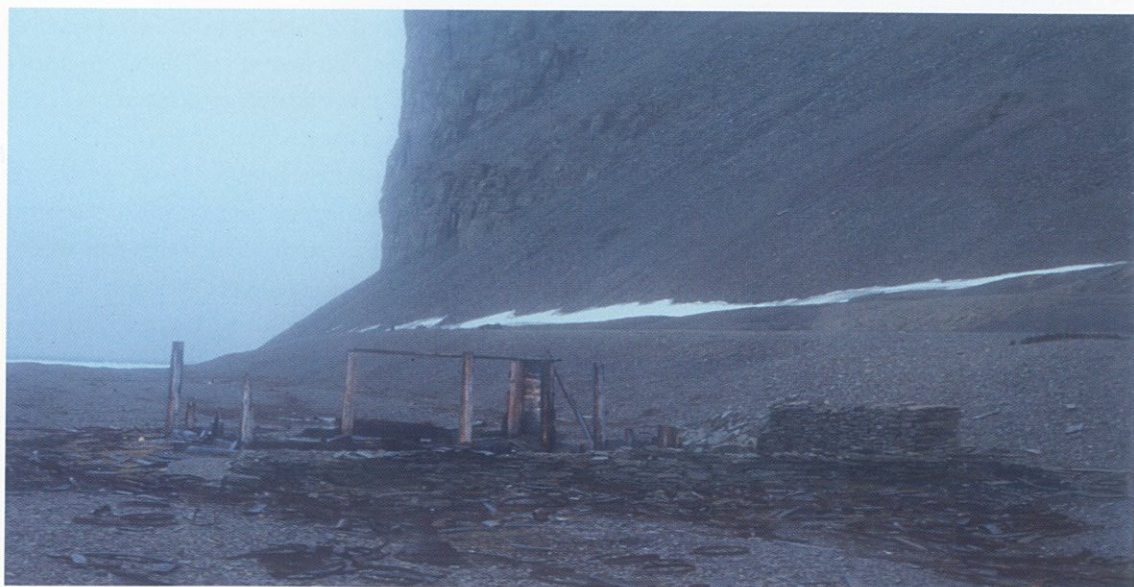
The remains of Northumberland House at Beechey Island built in 1852 by members of the Belcher squadron during a Franklin rescue expedition. Photo: R.A. Blanchette

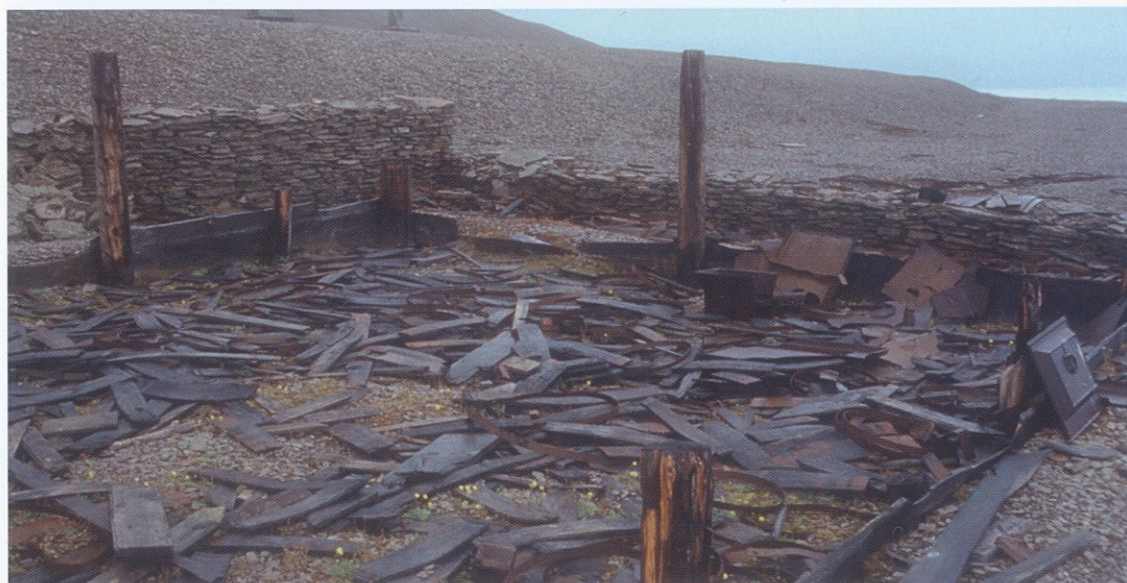
Wall boards, posts and various wooden artifacts associated with Northumberland House. This wood at Beechey Island is some of the oldest wood introduced into the Arctic by European explorers. Extensive decay is present in the wood and decay fungi are actively causing degradation.
Photo: R. A. Blanchette

numbers of the house posts and wall boards are on the ground within and around the location of the original structure. The structural wood present at the site is spruce, hard pine (most likely *Picea abies* and *Pinus sylvestris*) and oak. Some woods are affected by salt deterioration and have white defibrated surfaces. This type of non-biological degradation occurs in wood of historic huts at other polar locations and has been well described from the expedition huts located in the Ross Sea Region of Antarctica (Blanchette et al. 2002). It is caused by the corrosion of wood cells due to the chemical attack on lignin. Salts migrate into wood and accumulate resulting in the chemical degradation of the middle lamella between cells (the cementing material that holds cells together) and cells separate. Over time the cells on the wood surfaces become defibrated and detach. This process is relatively slow and gradually erodes the wood. Of greater importance is the destruction of wood by wood decay fungi. All woods have evidence of decay and many are affected with advanced stages of decay. There are several types of wood decay that occur throughout the world but only one form of degradation was found. This decay was characterized by cavities forming inside the secondary walls of wood cells and is commonly referred to as soft rot. Other types of wood decay, normally found in temperate regions of the world, were not found. Isolations from the decayed wood produced cultures that were identified by sequenc-

ing of the ITS region of rDNA. Many of the fungi obtained were *Cadophora* species that cause soft rot. Species of this genus have recently been found attacking wood in many locations in Antarctica and current information suggests that these decay fungi are indigenous to Polar Regions (Arenz et al. 2006, Blanchette et al. 2004). The wood from Northumberland House has been in the arctic environment for over 150 years. Decay fungi have slowly caused considerable degradation and strength losses to the historic wood over the past many decades. The fungi are still active in the woods and continue to cause decay when the moisture and temperature conditions are favorable for degradation to occur.

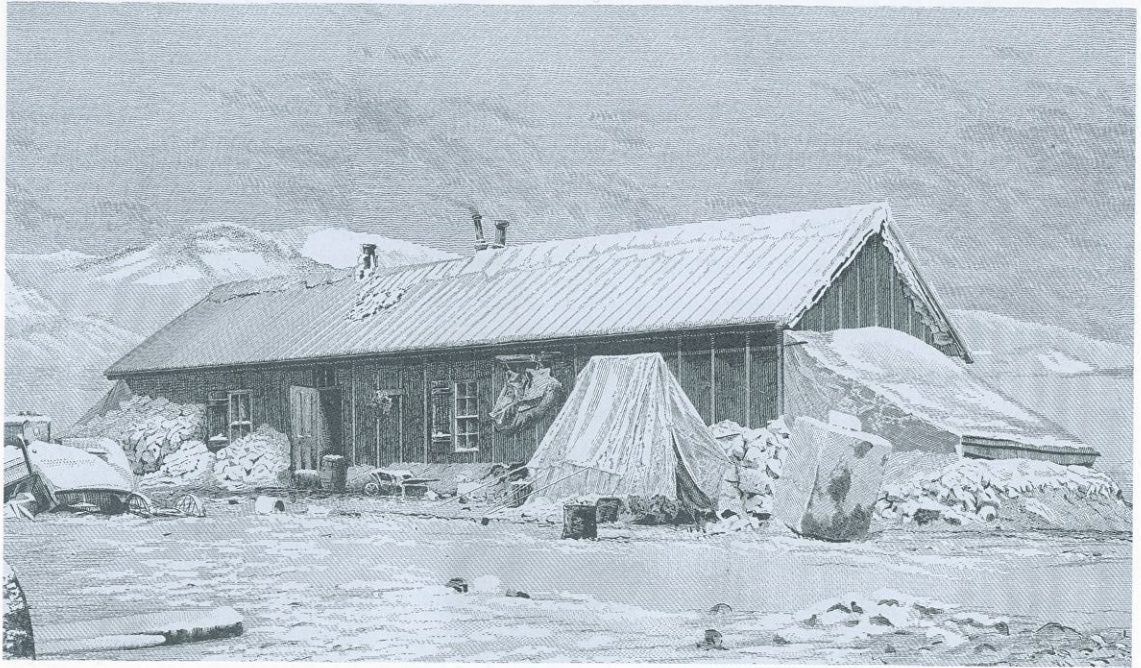
An illustration of Fort Conger as it appeared in 1881 (from Greely 1886). The structure was built by a U.S. army expedition led by Adolphus Greely and served to house the men and act as a research station during the first International Polar Year.

Fort Conger was a massive structure that was 18 m long, 5 m wide and had a 3 m high ceiling. It took enormous amounts of coal to heat the structure and was not well suited to the severe arctic environment. Robert Peary, who made many expeditions to the Arctic from 1890 to 1909, decided in 1900 to use Fort Conger as a wintering base. Robert Peary considered Fort Conger to be “a great barn of a structure ... grotesque in its utter unfitness and unsuitableness for polar winter quarters” (Peary 1917) and his crew of Mathew Henson, Dr. T. S. Dedrick and several Inuit dismantled most of Fort Conger and erected several small wooden shelters. The igloo-sized shelters were 2.5 to 3 m long and 2 to 3 m wide and were built low into the ground (Dick 2001). The huts were connected by a series of canvas covered passageways that became covered with hardened snow. Instead of a wooden hut, Peary decided to build a tent dwelling for his own living quarters that was covered by mattresses from Greely’s Fort. Snow and ice was used to cover the tent and mattresses, providing a solid layer of insulation. Subsequent expeditions by American, Norwegian, Danish, and British/Canadian expeditions in 1915, 1920, 1921, and 1935 also used the structures and supplies left at the site. Today, Peary’s tent cannot be found but the wooden structures and many other materials still remain at the site. The huts and wooden artifacts, however, are in various states of deterioration.

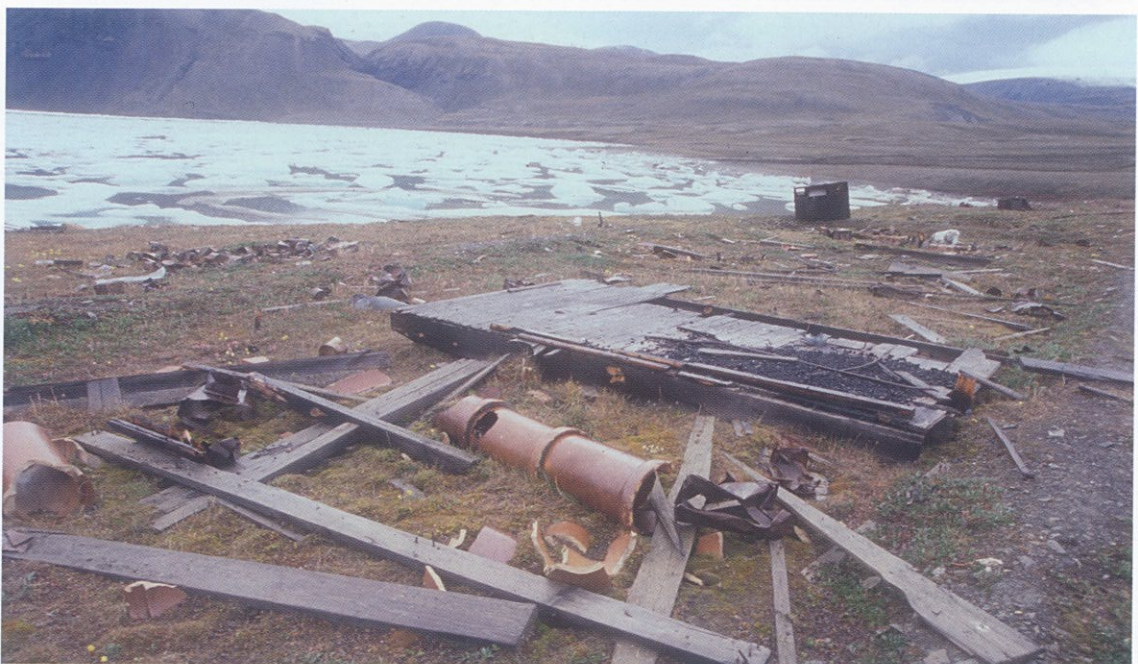
Little remains of the original Fort Conger due to dismantling by Peary and his expedition crew members in 1901 to make smaller dwellings for overwintering. Parts of the Fort's wooden floor, miscellaneous timbers and many artifacts are still at the site. Photo: R.A. Blanchette

The dismantling of Fort Conger by Peary and his crew left little of the original wooden structure at the site. Some foundation posts, beams and floor boards remain as well as many miscellaneous pieces of structural wood and wooden artifacts that are dispersed across a large area along the shore of Lady Franklin Bay. The largest section of floor remaining, approximately 4 x 2 meters, has floorboards raised 18 cm above the ground on sleepers running across the width. Many other artifacts made from metal, glass and other materials are also

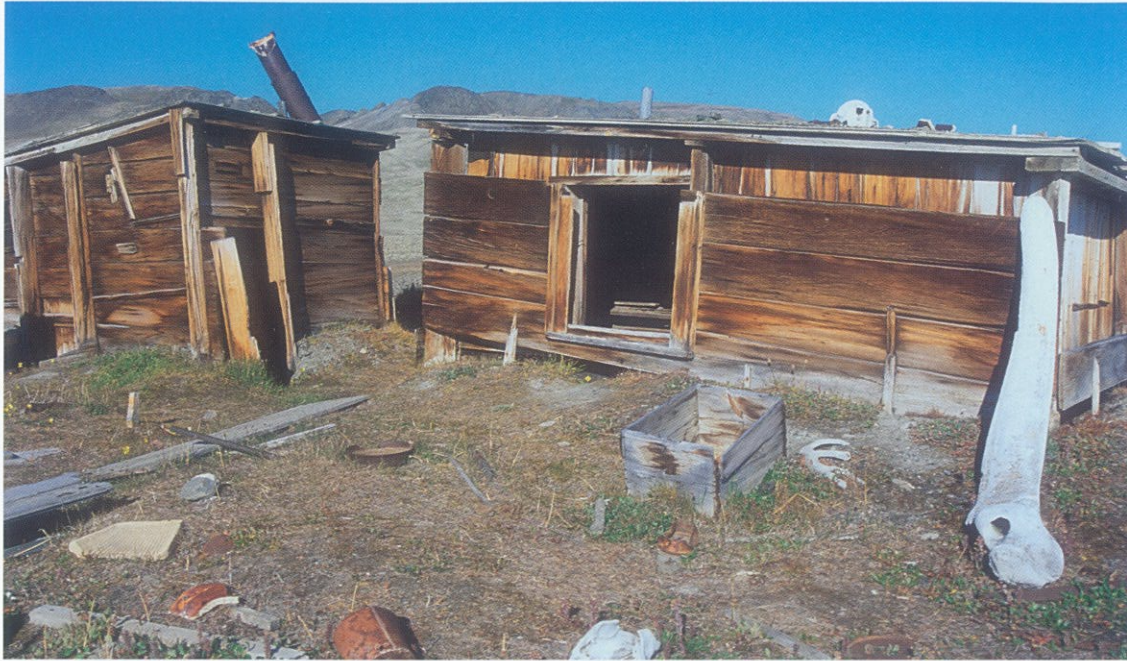
Structures built by Peary and his crew using wood from Fort Conger. Few people know that these historic structures are still present on the shores of Lady Franklin Bay and relatively little information has been published about them. Hut used by Matthew Henson is on right and T. S. Dedrick's hut is at left.

The Peary huts, individually called the Henson, Dedrick or the Inuit hut, were made with an unusual construction consisting of many layers including paper on the inside of tongue-and-groove boards, tar paper, silt and gravel in a 15 cm space, another wall of wood and exterior tar paper (Phillips et al. 1978). These multi-layered "soil" insulated wooden walls were covered with mounds of earth and turf as well as snow and ice in the winter. The huts were built into the ground and the floor of the hut was approximately 40 cm below the ground surface. Additional details on hut construction can be found in an archaeological report by Phillips et al. (1978). Most of the outer wall boards are missing from the huts but a few locations still have the double wall construction sandwiching the soil and gravel. One of these boards on Dedrick's hut bears the inscription, CHIEF SIGNAL OFFICER/WASHINGTON DC USA, and is from the Greely Expedition. Windows and doors are open and the roof has blown off the Inuit hut. It can be found on the ground several meters away. One of the first photographs taken of the huts in 1935 (Shackleton 1938) suggests that the roof may have been off the hut since that time (Phillips et al. 1978).

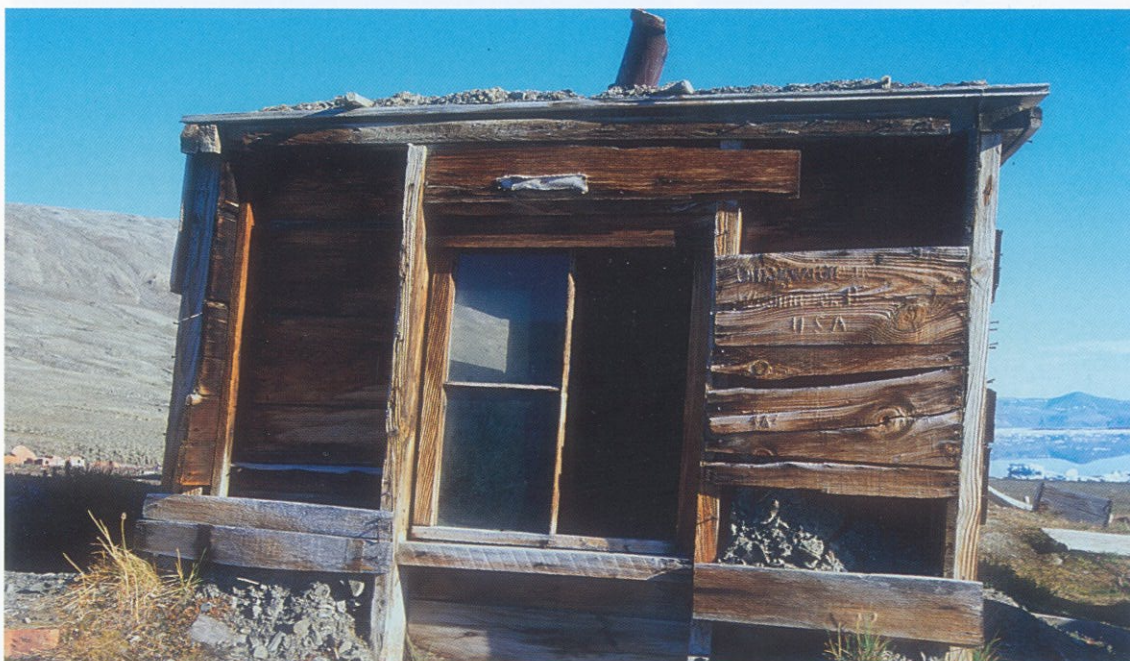
The Dedrick hut at Fort Conger. All three hut structures used by the Peary expedition have had serious deterioration over the past decades and the degradation processes continue unabated. Outer boards of the hut's multi-layered wall construction have blown off, windows and doors are open and the roof has blown off one hut. Non-biological deterioration (wind erosion and salt corrosion) as well as decay by wood destroying fungi has severely affected the wood in the huts.

The effects of serious wood-deterioration are clearly evident on the hut woods. Wind has eroded the surfaces of the outer boards that remained on the structures producing a grooved appearance where early-wood cells of the annual rings have eroded faster than the more resilient latewood regions. The sand and ice blasting that affected the wood was tempered in places where the wood has some protection. Even paint, used to write an inscription, can protect the underlying wood. However, the historic inscription on the outer boards of the Dedrick hut originally from Greely's 1881 expedition, is becoming worn and unreadable due to its age and the severe wind erosion that occurs. Some wood throughout the site also has evidence of salt damage, but precipitation appears sufficient at the site to leech excessively high concentrations of salt from the wood and this form of deterioration is limited. Most significant is the degradation of wood taking place by wood-destroying fungi. Advanced decay is evident in all wood in ground contact and varying stages of decay are found in woods located above ground. Since the huts were built low into the ground, moisture easily accumulates inside and provides conditions that are ideal for decay to take place. Wood inside the huts is so decayed that it is soft to the touch. Although the decay can appear brown in color and look like a brown rot form of degradation, microscopic examination indicates that all of the decay found in all woods at the site is

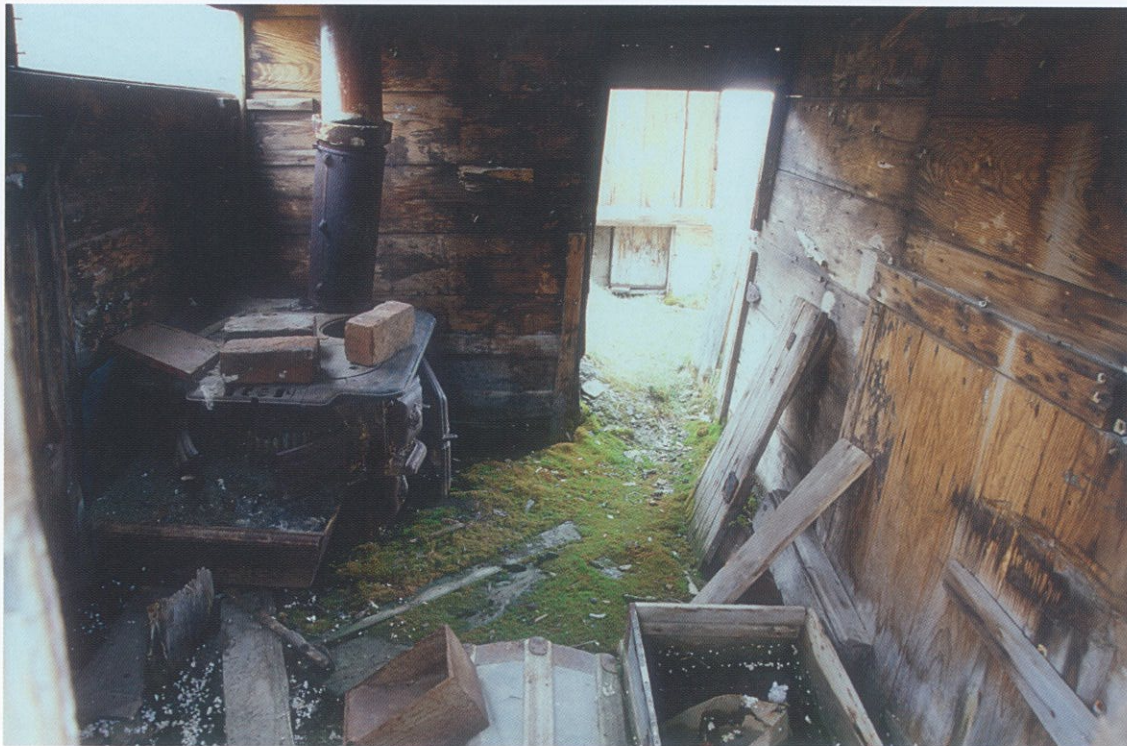
The remains inside the Dedrick hut showing stove and other materials that were left. The huts were built low into the ground which has resulted in moisture accumulation and very wet conditions inside the hut. Conditions are favorable for decay and soft rot fungi have caused extensive degradation in the wooden structure and wooden artifacts. Photo: R.A. Blanchette

Environmental monitoring of temperature and relative humidity was done inside Henson's hut and the Dedrick hut over a two year period. Conditions suitable for decay were found for long periods of time during the summer months. Moisture levels appeared conducive for decay and temperatures were above freezing for 1810 to 2185 hours per year. During the first International Polar Year, Greely's expedition members monitored temperature and found in 1881 and 1882 that there were 1588 and 1691 hours respectively above 0° C (Greely 1888). In comparison to environmental data recently obtained in our investigations, there was approximately 2000 hours per year above 0° C or about 500 more hours per year than when the huts were built. Although only 2 years of data are being compared and more monitoring needs to be done to determine if this is an ongoing trend, any increase in temperature will allow additional time for fungi to grow and metabolize their substrate resulting in greater amounts of decay. Fungi are well adapted to respond quickly to environmental change and apparently can utilize increases in temperature to their advantage to grow longer and have increased decay rates (Gange et al. 2007). Warming trends in the Arctic will undoubtedly have a continued detrimental effect on historic woods by providing more time for these unusual wood destroying fungi to actively cause decay.

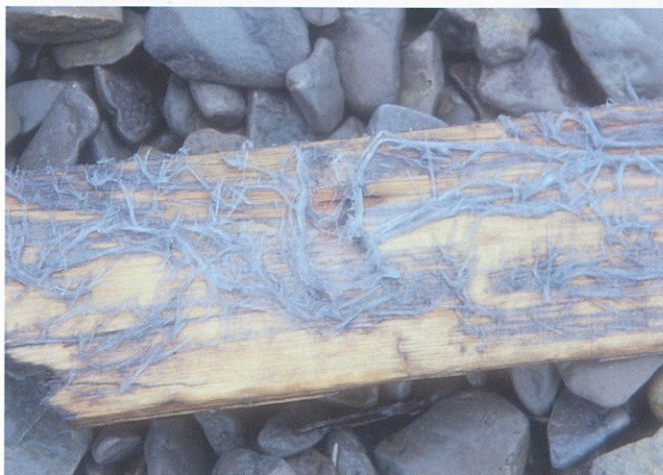
Defibration of wood surfaces was found on some woods at Beechey Island and at Fort Conger. Salt accumulation is responsible for causing a chemical attack on wood that results in the separation and detachment of wood cells. Loose surface wood fibers are eroded off exposing new cells to the corrosive action of the salts. Both photos: R.A. Blanchette

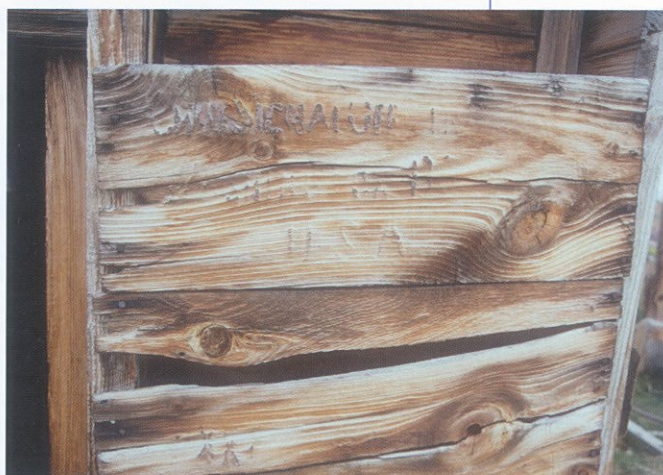
The effects of wind erosion on outer boards of Dedrick's hut cause deep grooves in the wood. The less dense earlywood cells of the wood are eroded faster than the latewood cells resulting in a grooved appearance. An inscription, "CHIEF SIGNAL OFFICER/WASHINGTON DC USA" placed on this reused wood during the Greely expedition (1881) has partially resisted the effects of the wind.
